Technical Service Handbook

Model description: **POLO A05 Ind.TREND 77 TDI M5F**

Technical product information

AC not working / refrigerant leakage from Evaporator

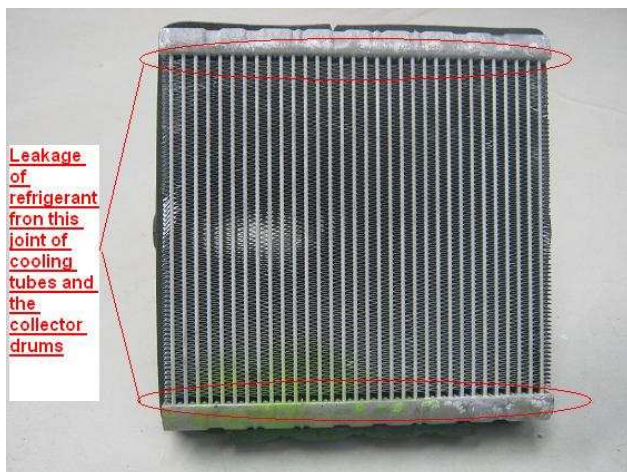
Leakage of AC refrigerant from Evaporator unit from the tube and drum / collector joint

If there is refrigerant leakage from somewhere else than the end tubes as shown in the below photograph (tube and collector joint), this TPI will not be applicable.

Step 1: Remove the defective evaporator unit as per ELSA Pro.

Step 2: Install a new evaporator unit having production date after 12th July' 2011 (to avoid repeat

repair) as per ELSA Pro.

Step 3: Refill the AC gas in the system. Check for refrigerant leakage and confirm the solution of the problem.

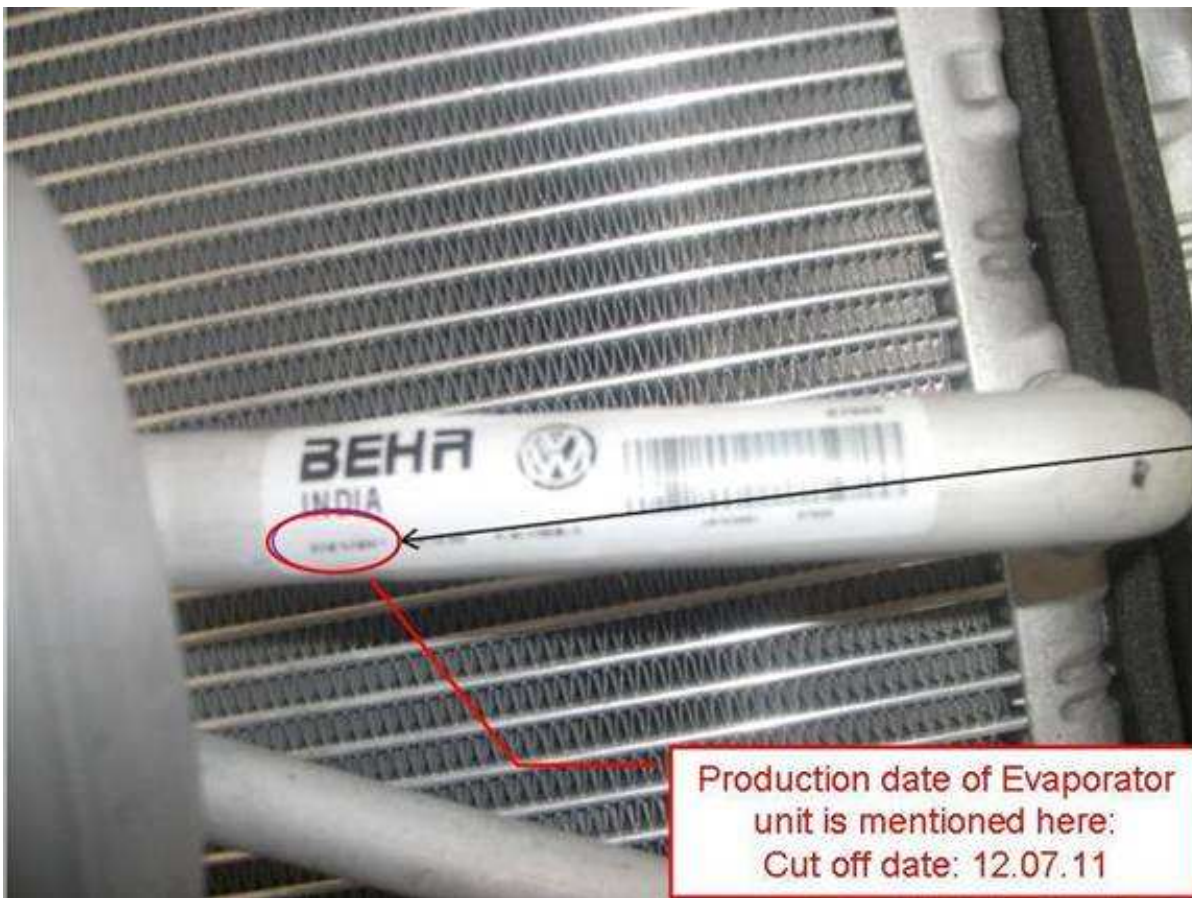
Further to verify the failed evaporator units, check for the date of production of the evaporator unit as shown in below photograph. All the evaporator units produced before 12th July'2011 are before cut off.

Old evaporator production date: before 12th July'2011

New Evaporators production date: 12th July'2011

Refer below photograph for checking the production date of Evaporator unit.

In case, the date of production of evaporator is **after 12th July - 11**, please carry out the following steps:

1. Check for leakage from the evaporator and **send a clear video showing the leakage point**.
2. Replace the evaporator unit and send it for analysis.
3. Always **attach the photograph of batch code sticker of the evaporator unit in the DISS Ticket**. Claim without batch code sticker is liable for rejection

In case, the date of production of evaporator is **before 12th July - 11**, No technical DISS ticket required, please carry out the following steps:

Always attach the **photograph of batch code sticker of the evaporator unit in the DISS Ticket**. Claim without batch code sticker is liable for rejection
