FINAL INVESTIGATION REPORT
ON ACCIDENT TO
JET AIRWAYS BOEING B-737-800 AIRCRAFT VT- JBG
AT GOA ON 27.12.2016

FINAL INVESTIGATION REPORT ON ACCIDENT TO JET AIRWAYS
BOEING B-737-800 AIRCRAFT VT- JBG AT GOA ON 27.12.2016

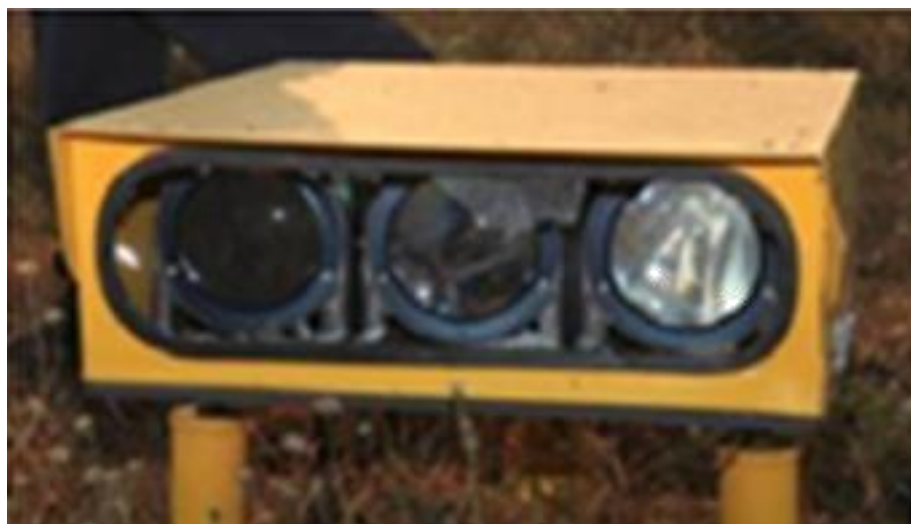
PAPI LIGHTS

The aircraft stopped at a distance of 219 m from the runway edge and just short of periphery road. During this trail it had hit PAPI lights.

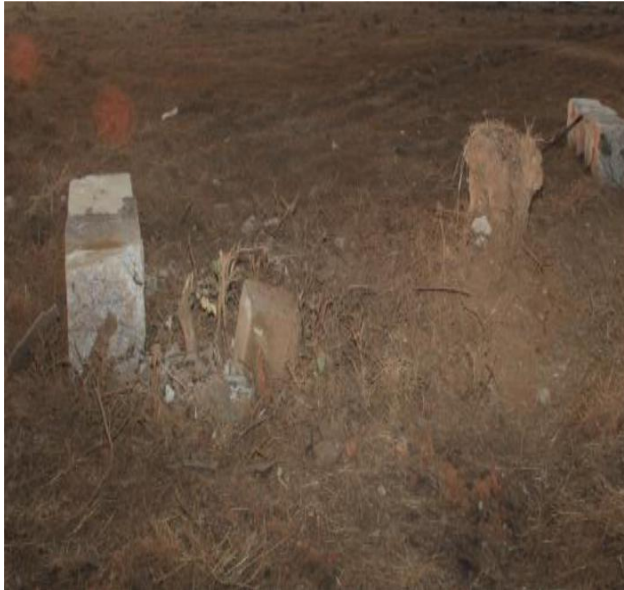
PILLARS (after aircraft impact)

Engine had hit vertical pillar of 2.3 m height, located at 92.3 m abeam center line of Runway 26. The pillar has also damaged the left bottom portion of the fuselage.

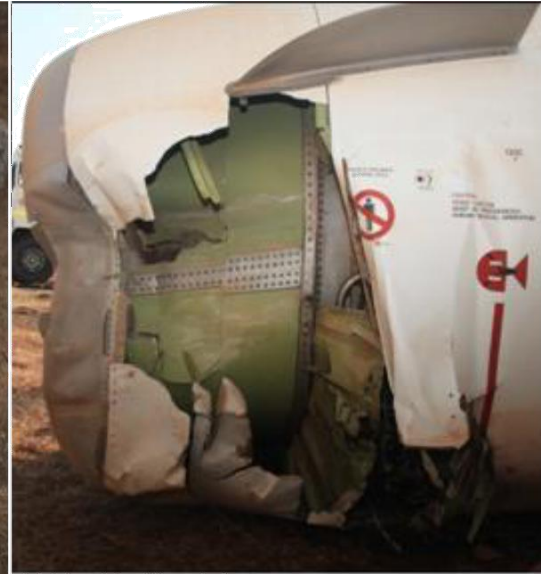
Engine damaged due hitting pillar

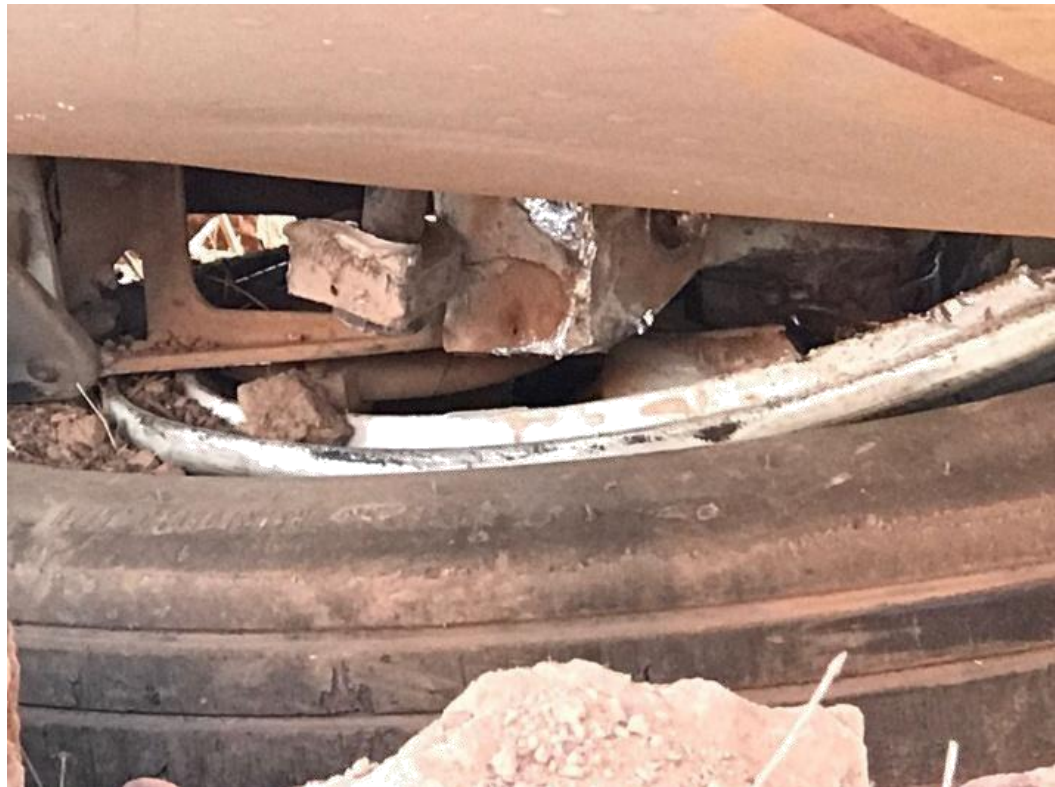
- Nose landing gear oleo got damaged and found completely buried under the aircraft nose.

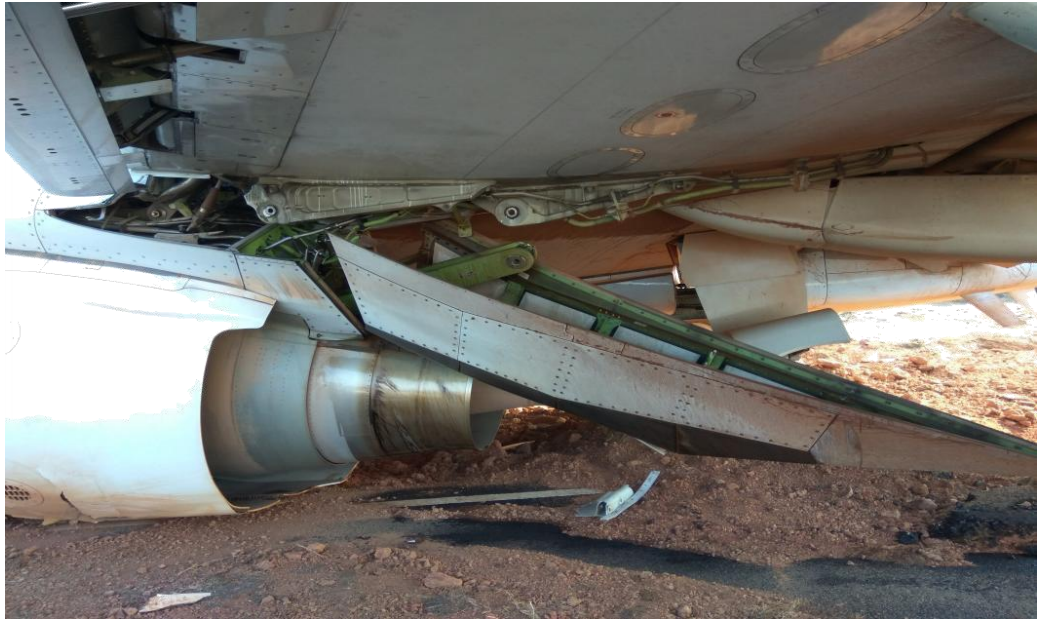
- LH engine pylon attachment broken.

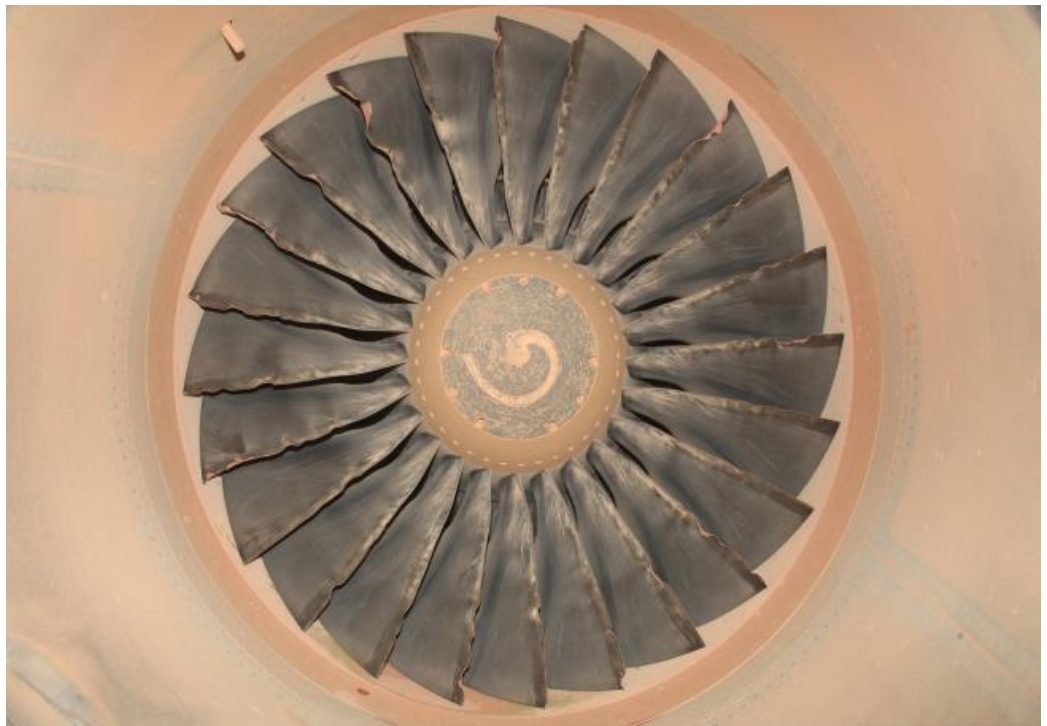
- Damage to LH engine fan blades.

- Air starter housing had a dent and crack.
- All the fan blades had nicks and tears. The fan Case lining was completely missing with parent metal exposed.

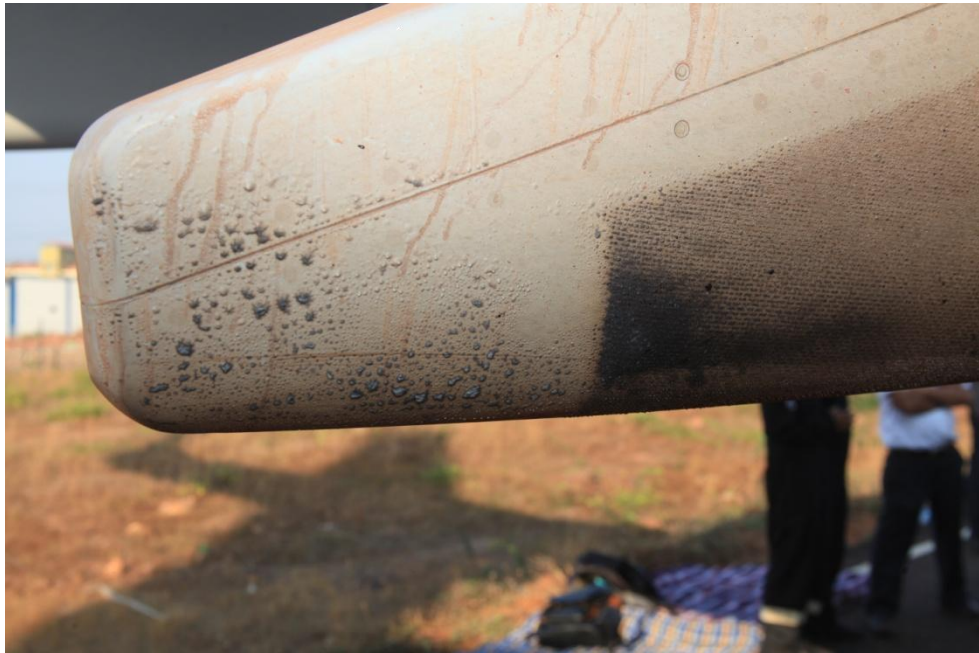
There was no fire barring that one of the flap track fairing had burn marks.

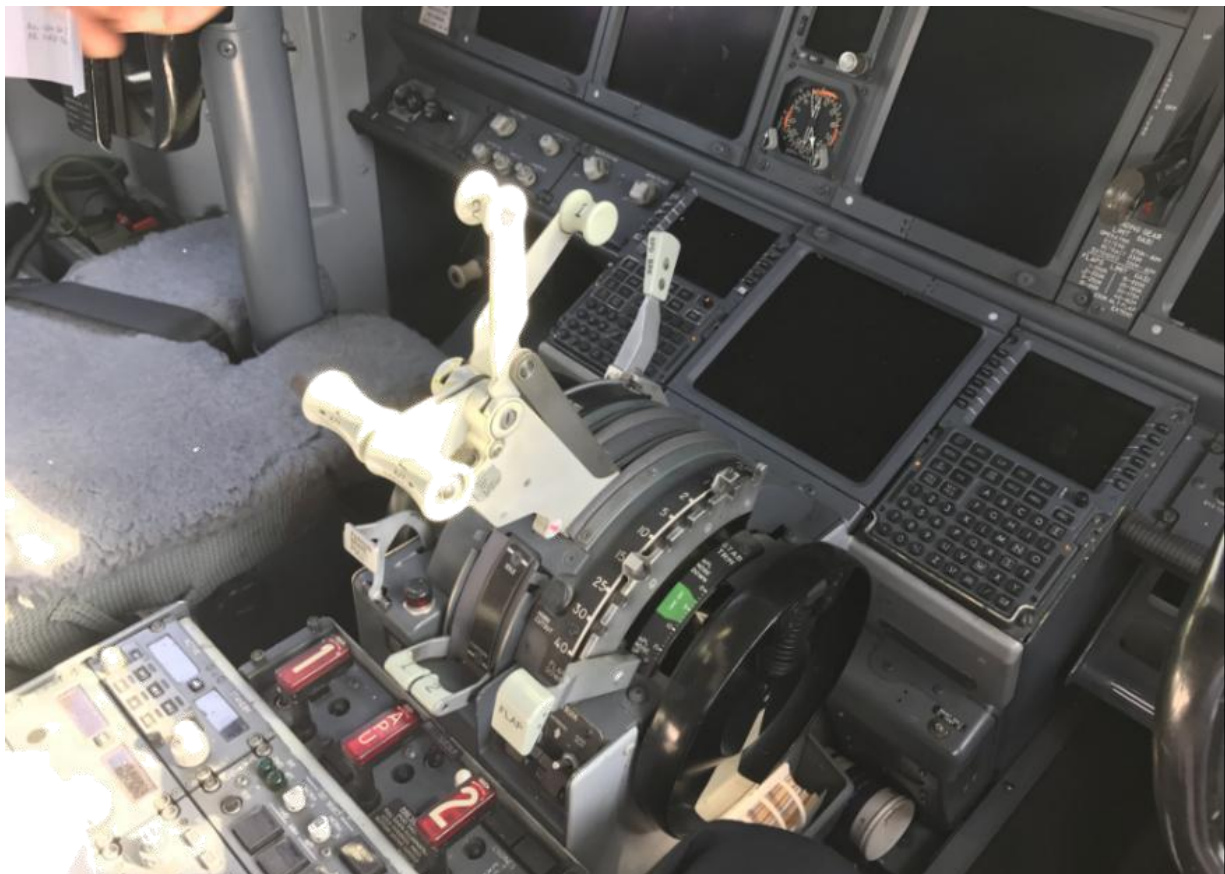
- The number two reverse thrust is fully deployed and the number one thrust lever is in the interlock stop position.
- The parking brake has been set and the speed brake lever is in the down detent

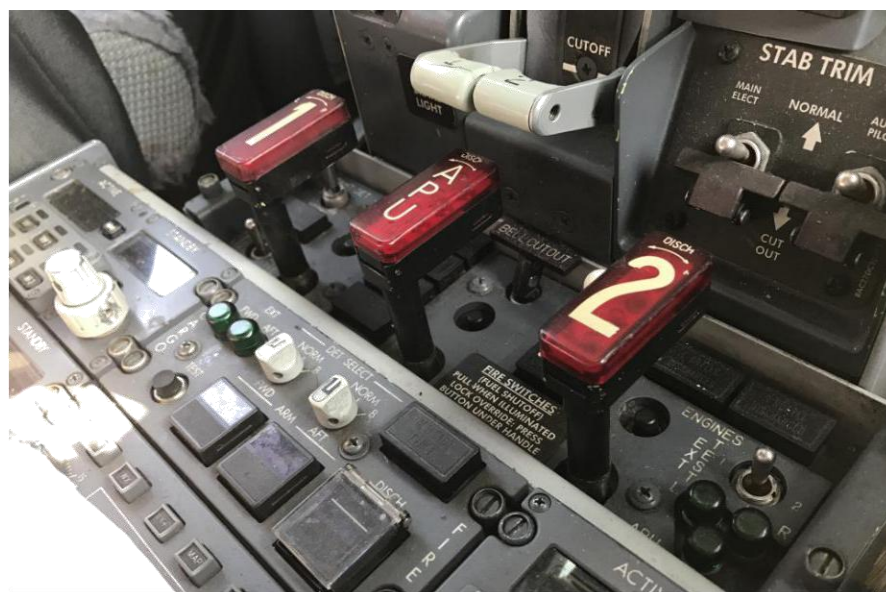
- Both start levers are moved to cutoff.
- The two engine fire switches and the APU fire switch have been pulled. These are in concurrence with the evacuation checklist
