**All BEFORE pictures were taken on 21<sup>st</sup> June 2023, before handing over car to workshop for replacing AC parts.**

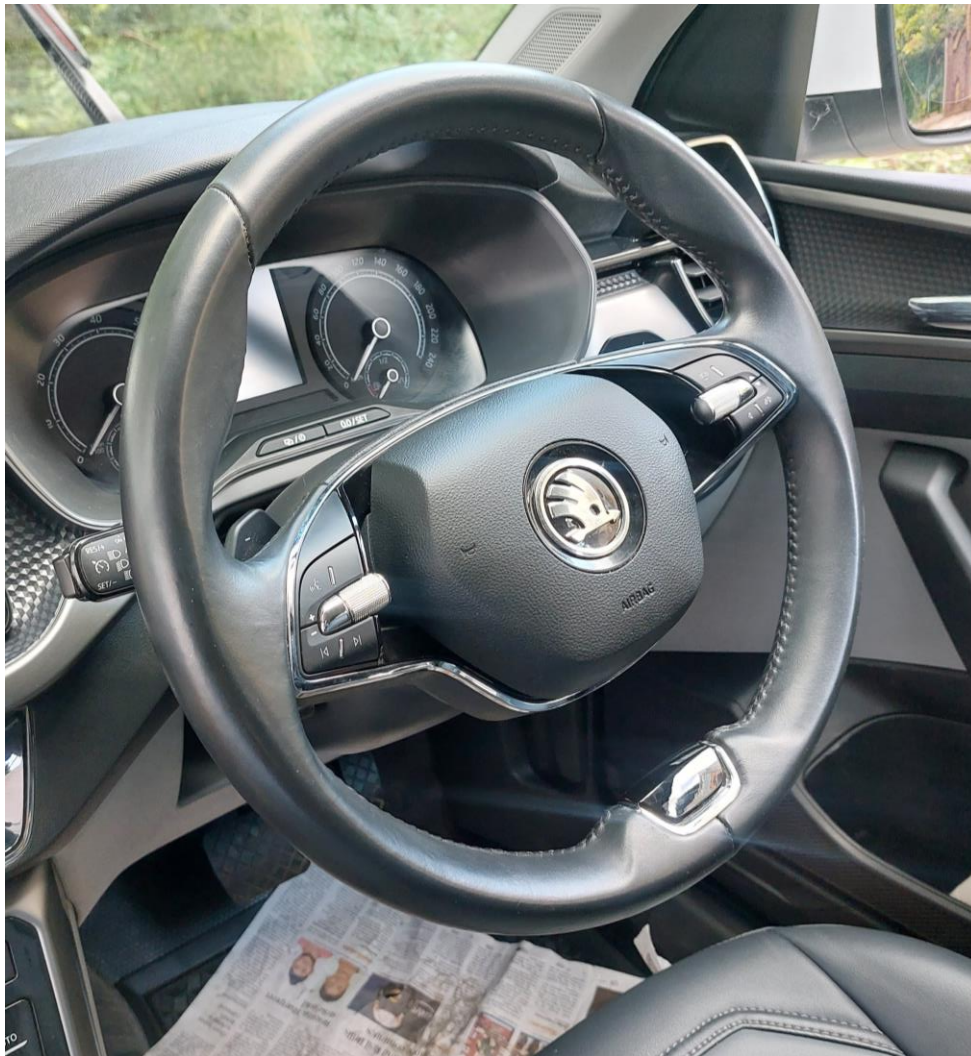
**BEFORE**

**No scratches visible in the  
BEFORE picture**

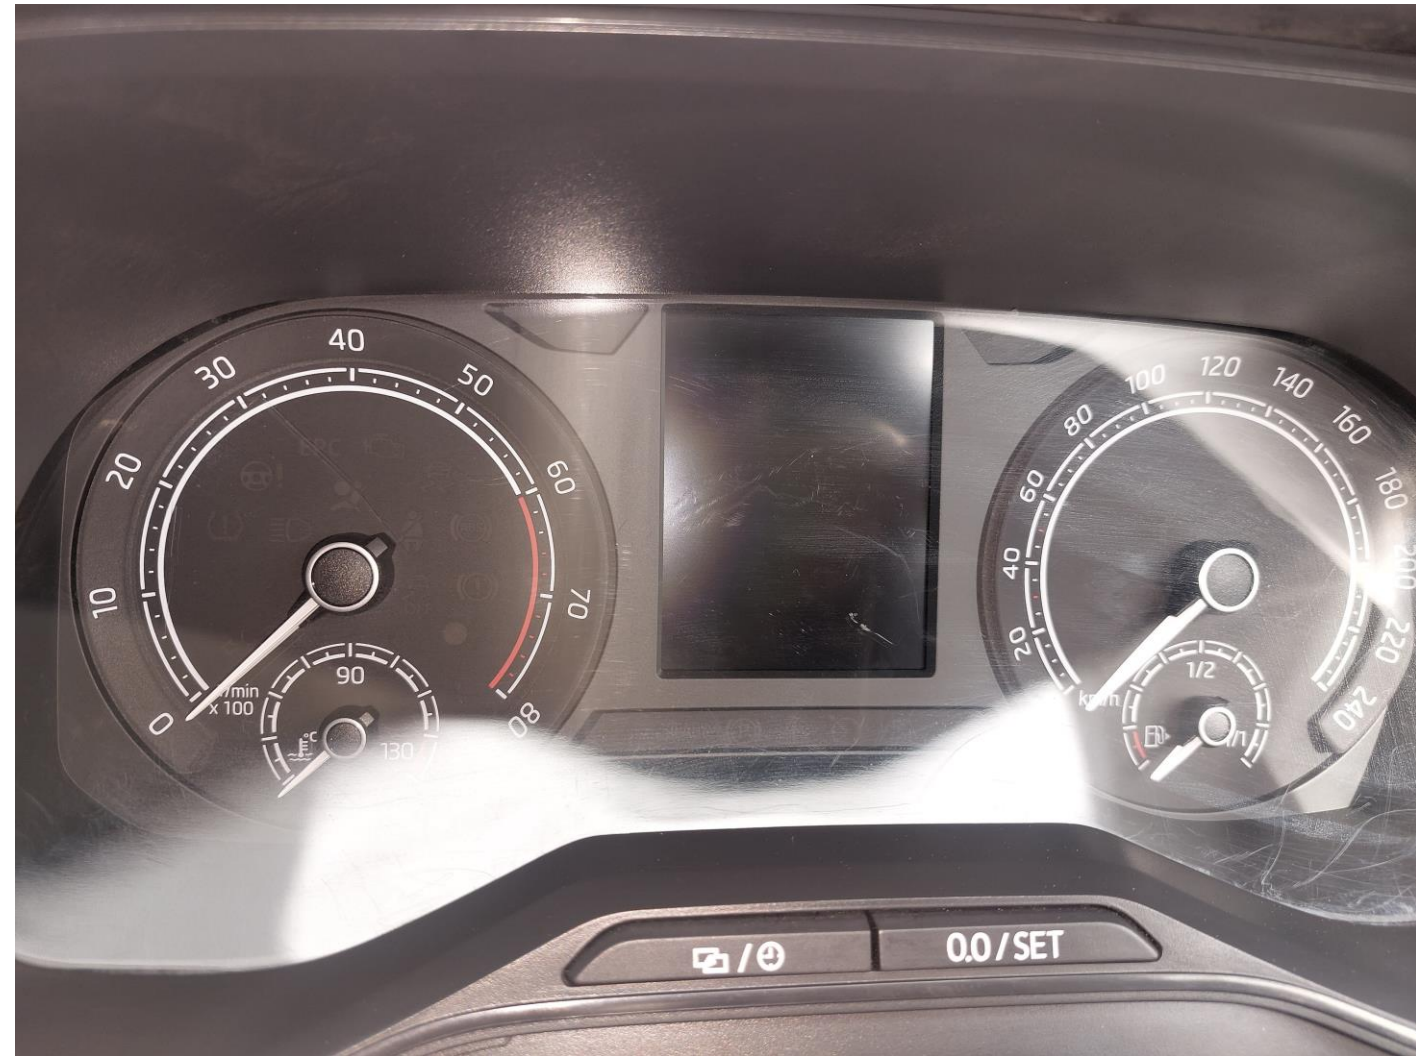
**AFTER**

**Full of scratches and damage to  
the whole glass/plastic panel**

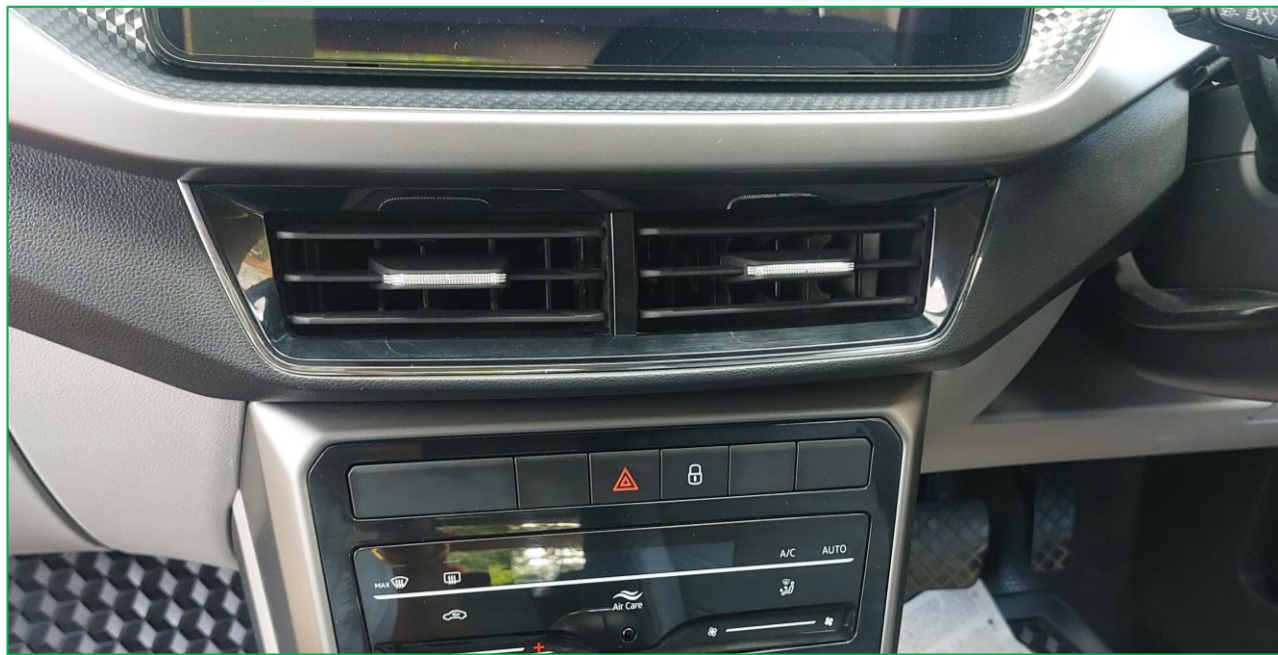
**BEFORE**

Only swirl marks visible on the trim around center AC Vent

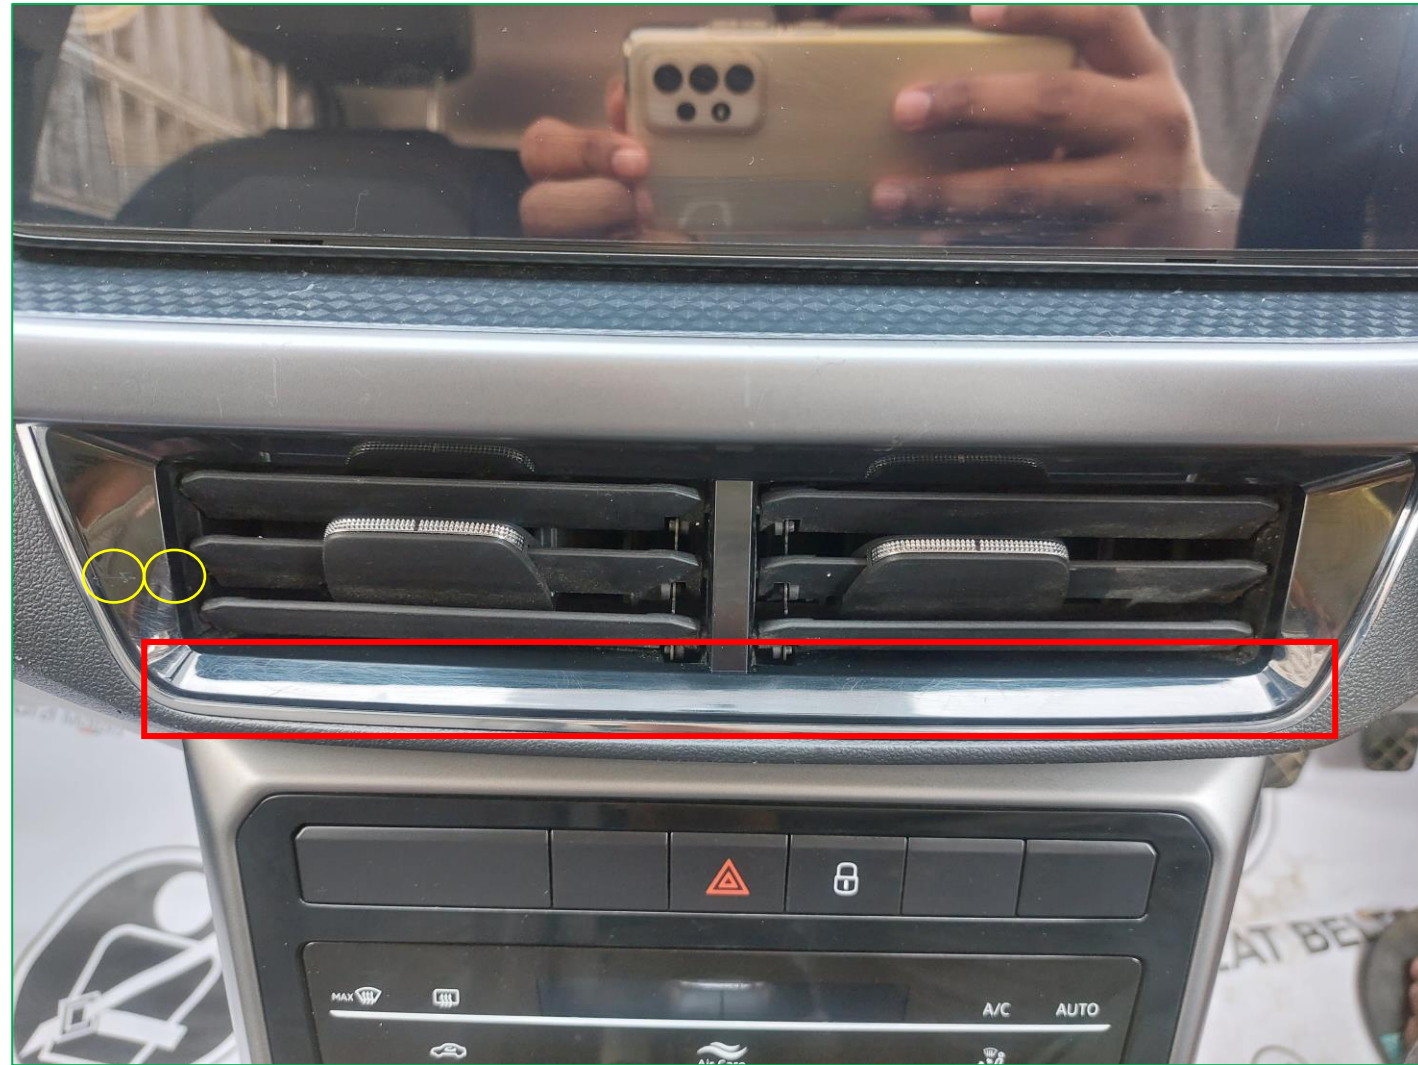
**AFTER**

Multiple scratches and damages.  
**Yellow marks** – Deep scratches resembling deliberate hit with hard tools/  
**Red Marks** – Scratches resembling improper handling and usage of tools

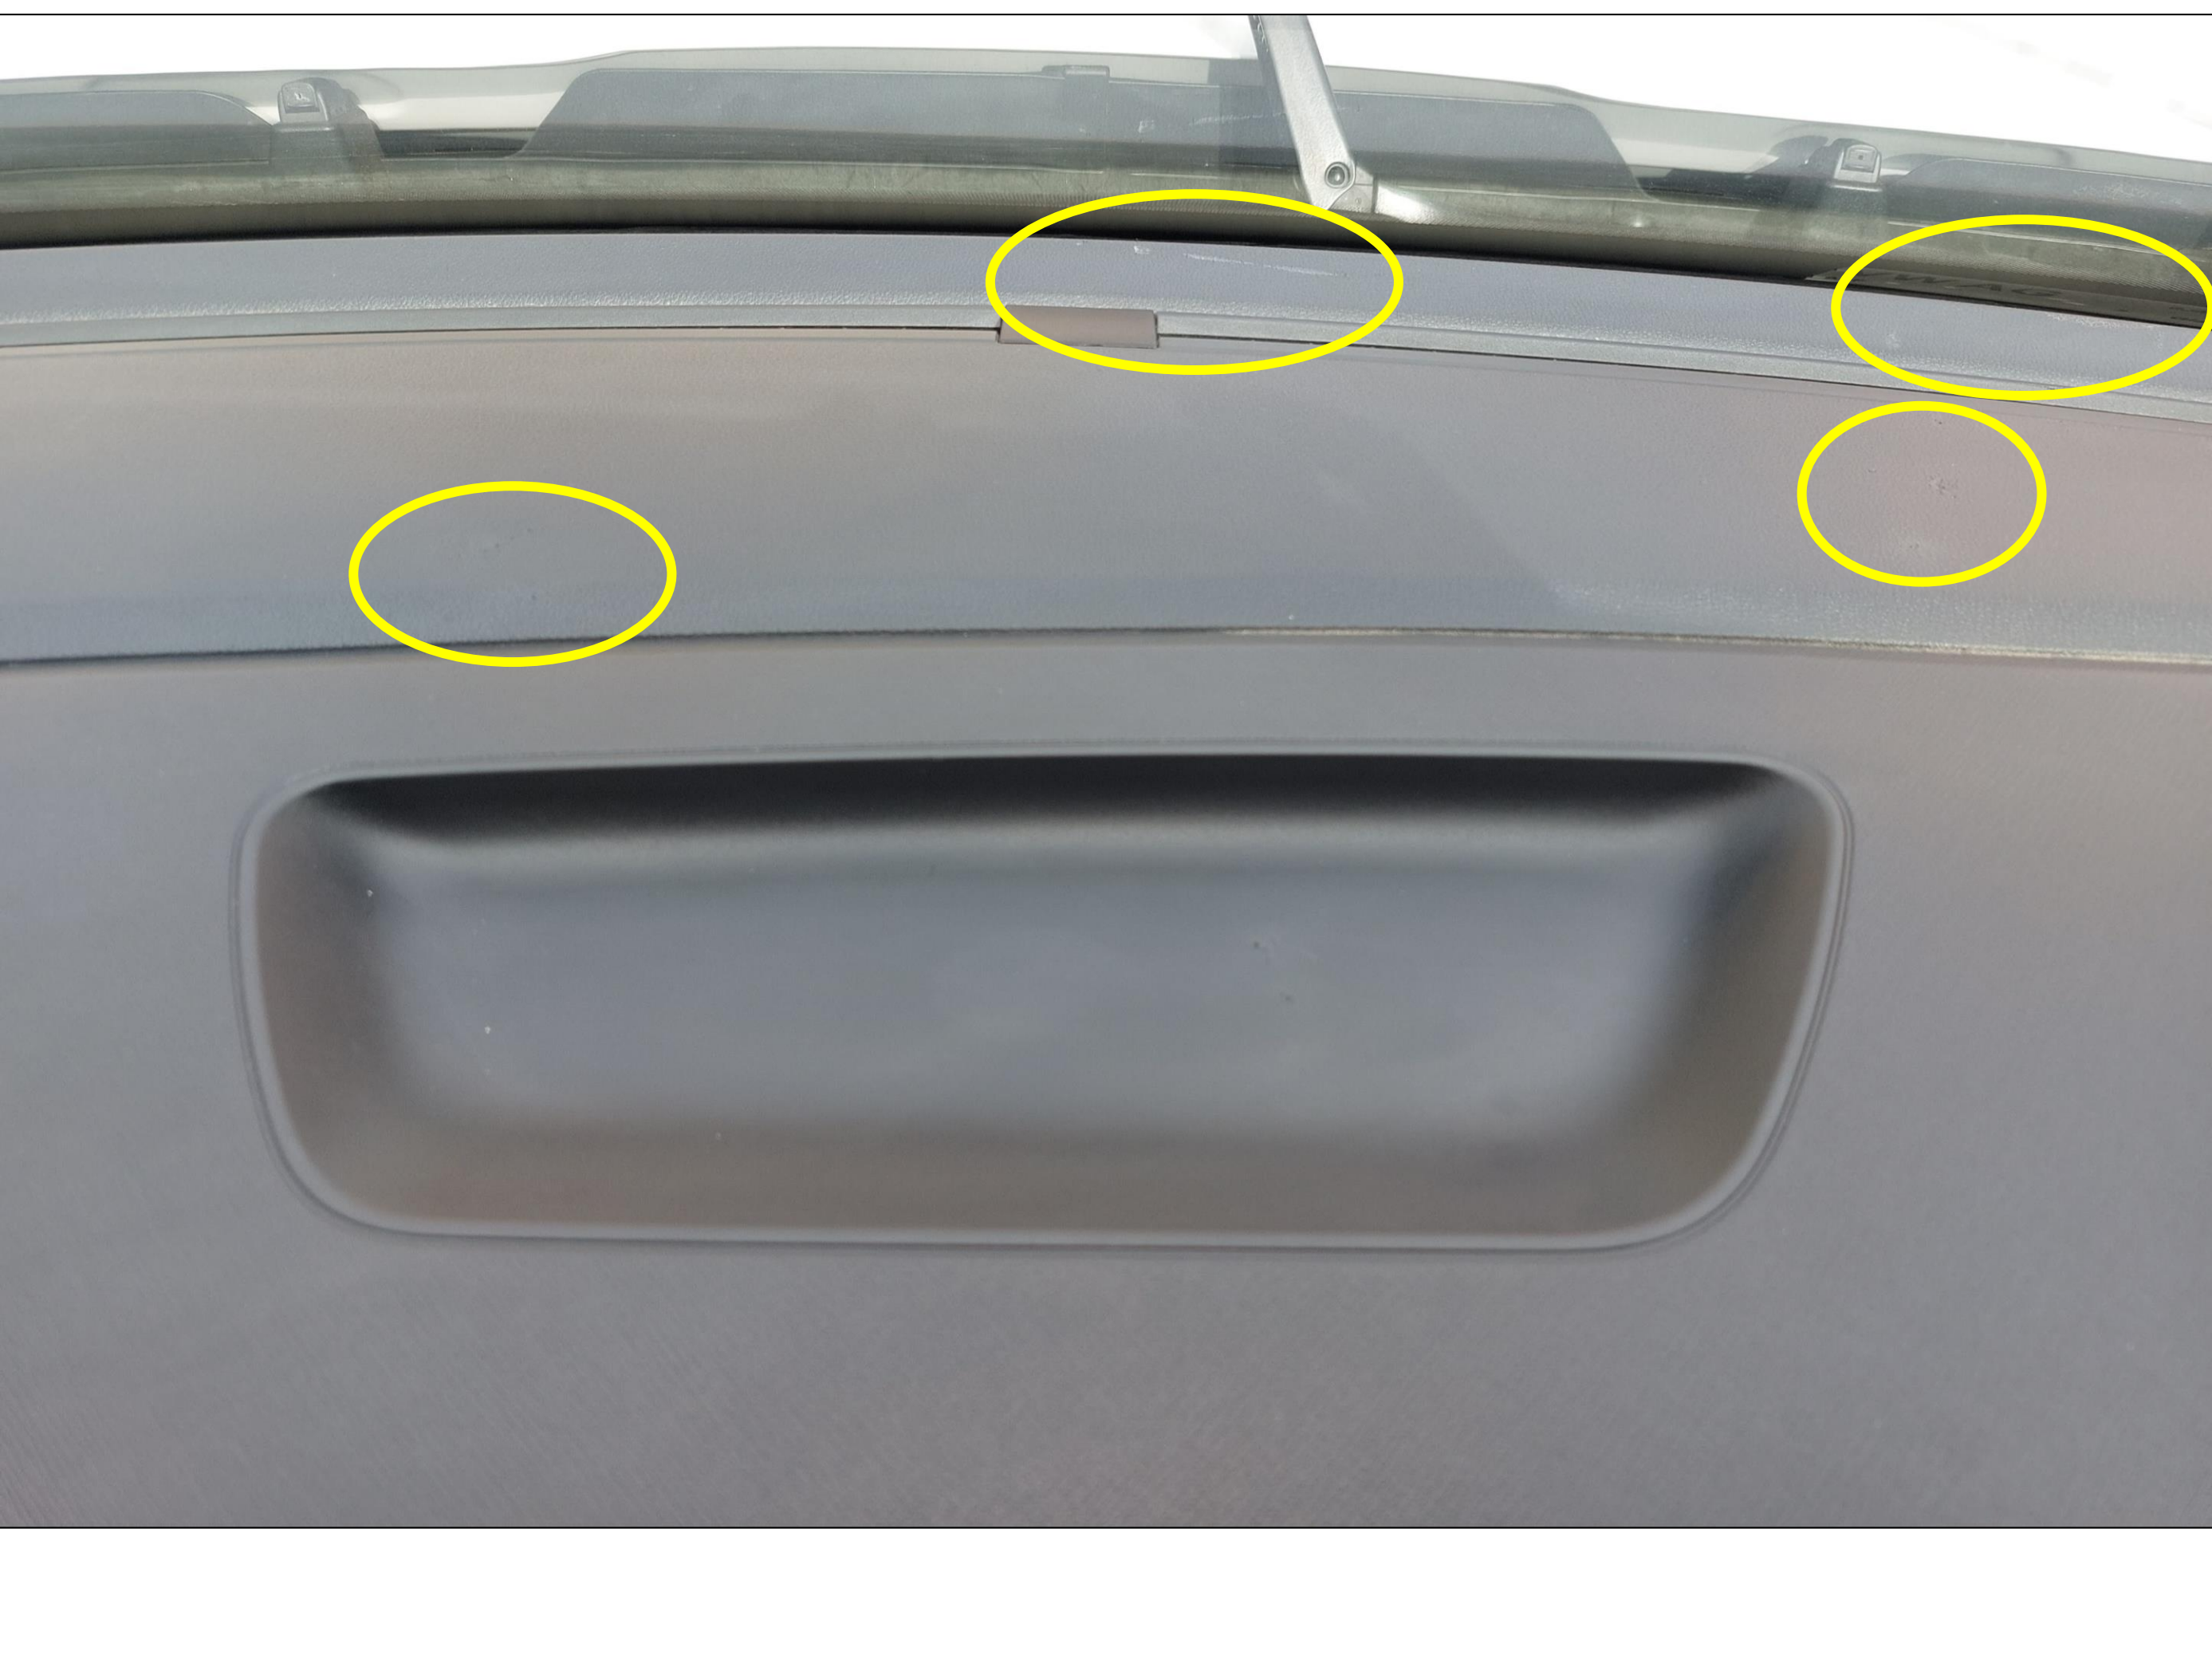
**One existing scratch next to deity**

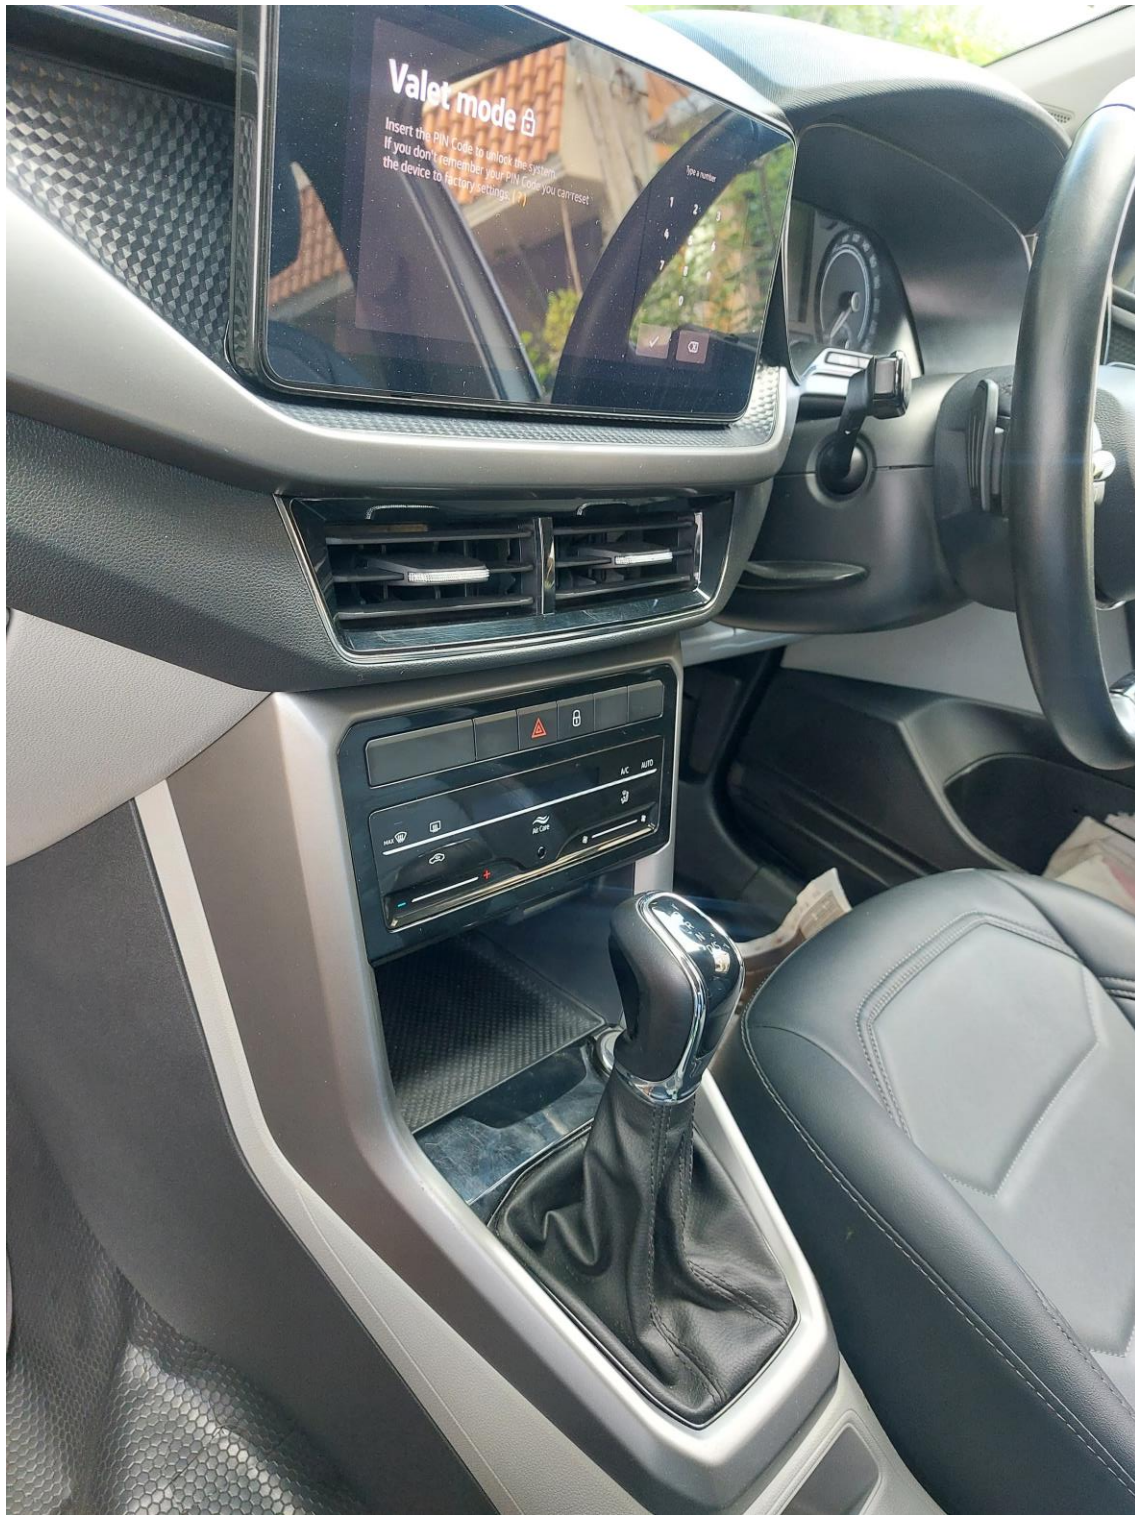
**BEFORE**

**No scratches/damages to trim  
below infotainment**

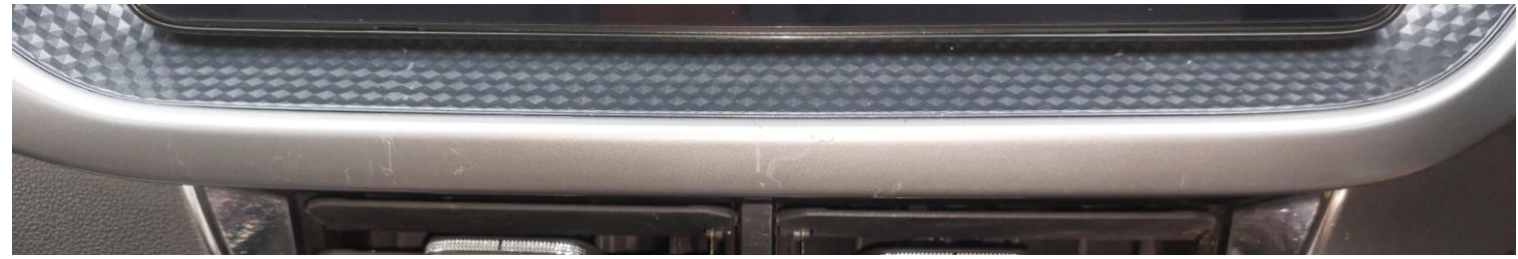
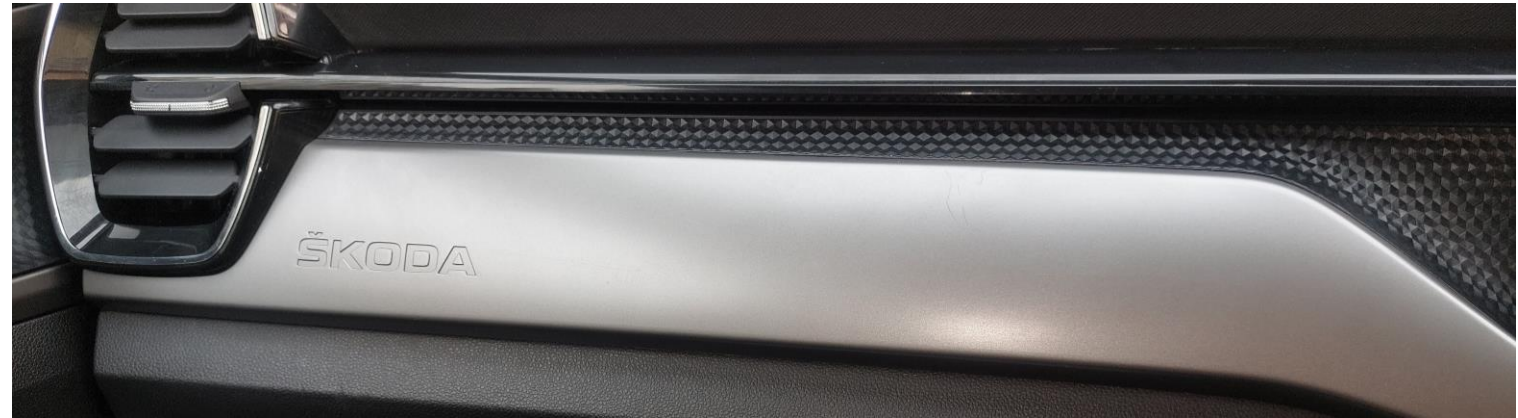
**AFTER**

**Deep scratches in the full trim  
below infotainment**

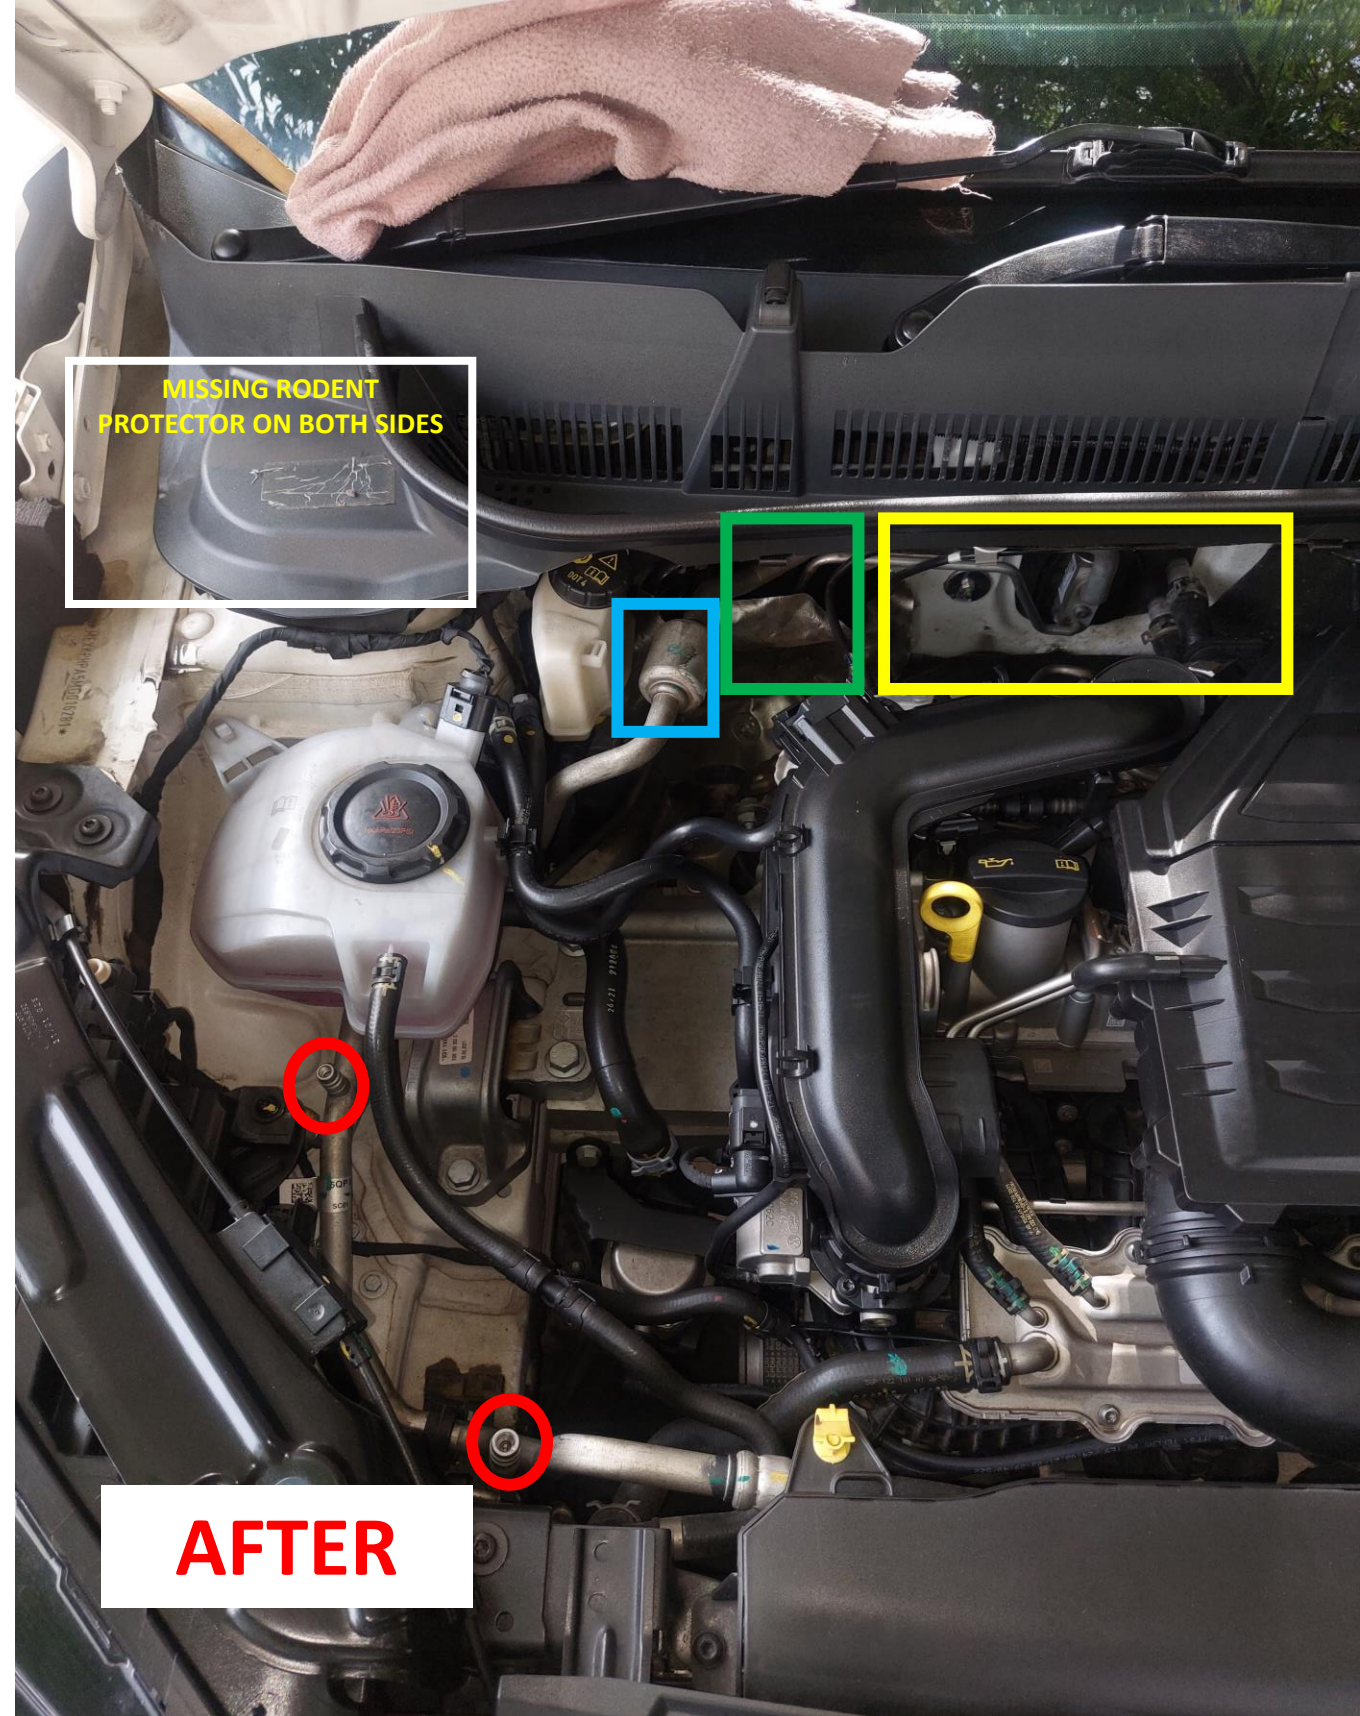
**AFTER**

- Red Circle:** Caps missing which were available before procedure. I do not want to risk another leakage due to a missing cap with quality of parts under question.
- Yellow Box:** Addition of new parts – A rectangular part is visible which wasn't available before. Observed this is a domestic made EGELHOF but I was apprised the whole system was made my MAHLE. Also missing black insulation cloth/cover
- Green Box:** The metallic heat insulator looks like is fixed with an after thought. The stock fit is missing.
- Blue Box:** Resemble bad handling of parts

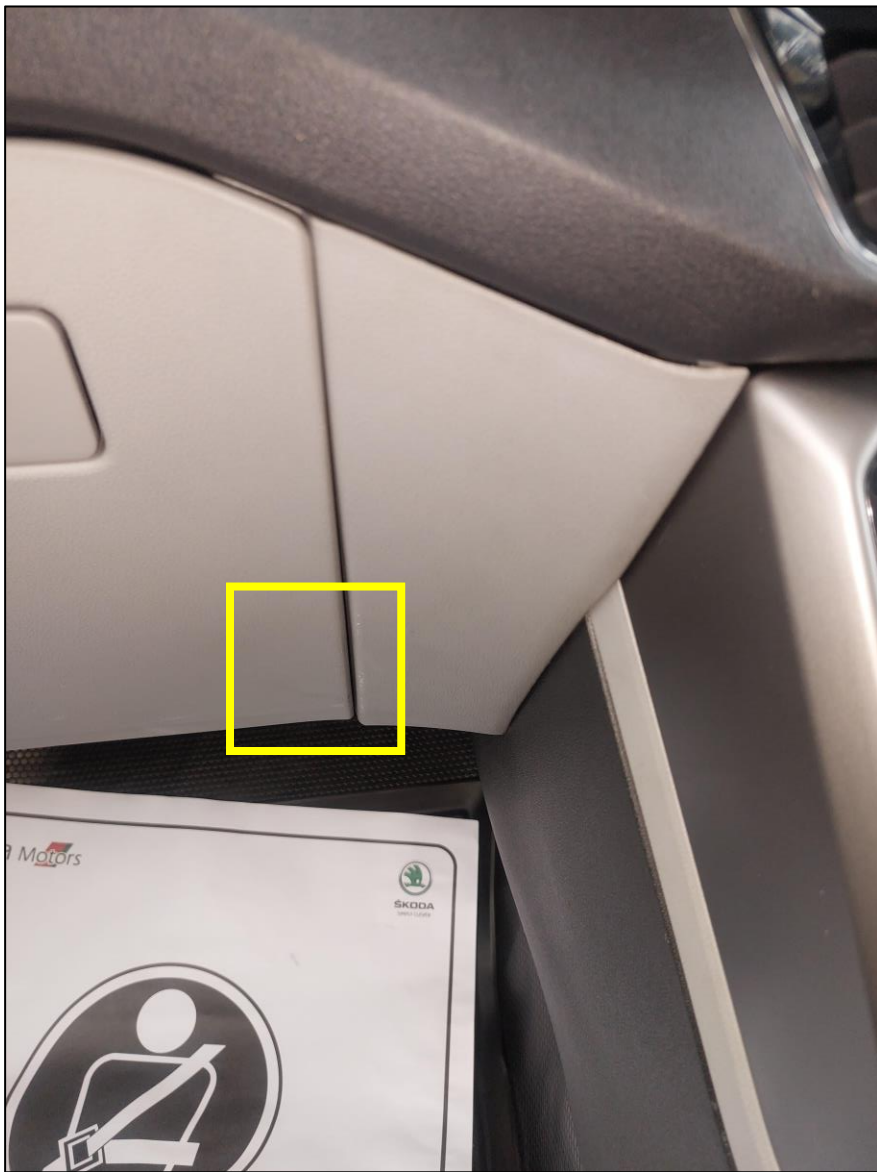
Damage to part outside glove box resembling damages due to bad usage of tools.

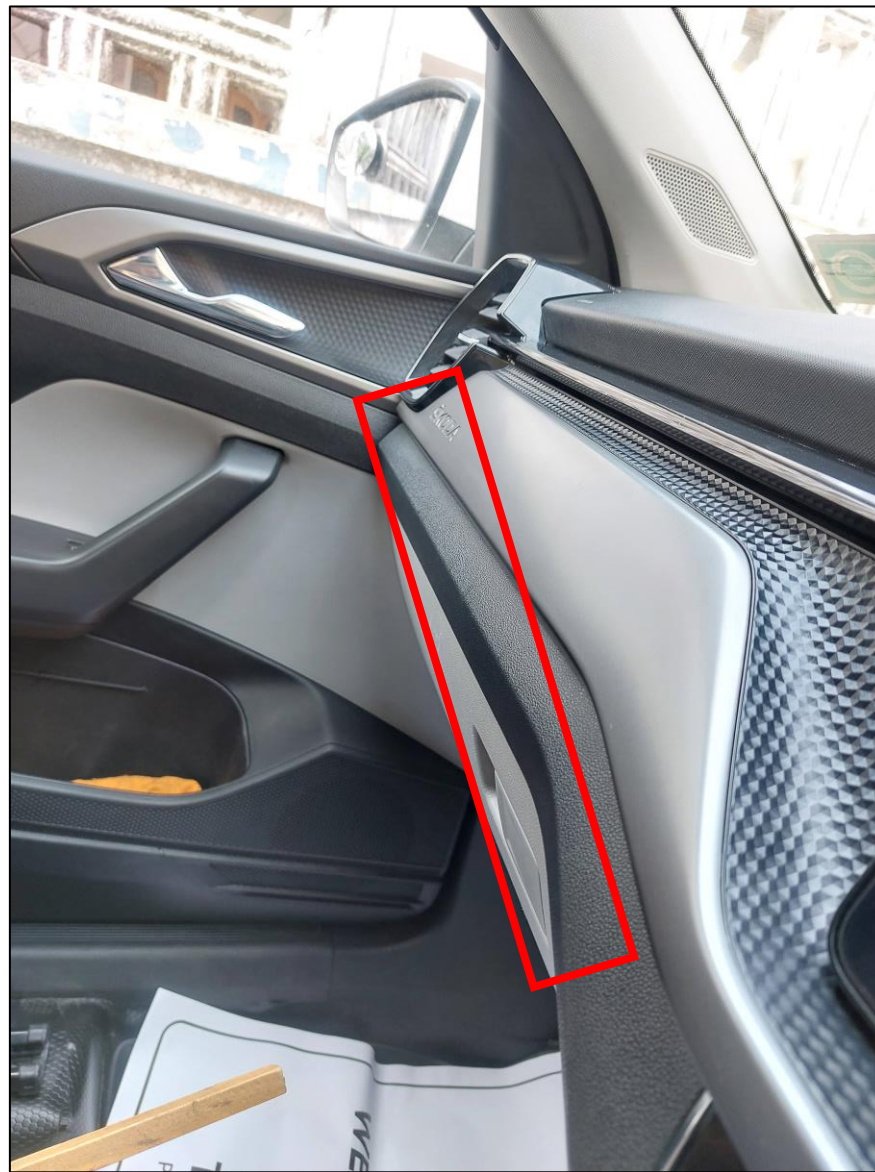
Multiple hard-pressed points resembling bad handling and placement post dis-assembly.

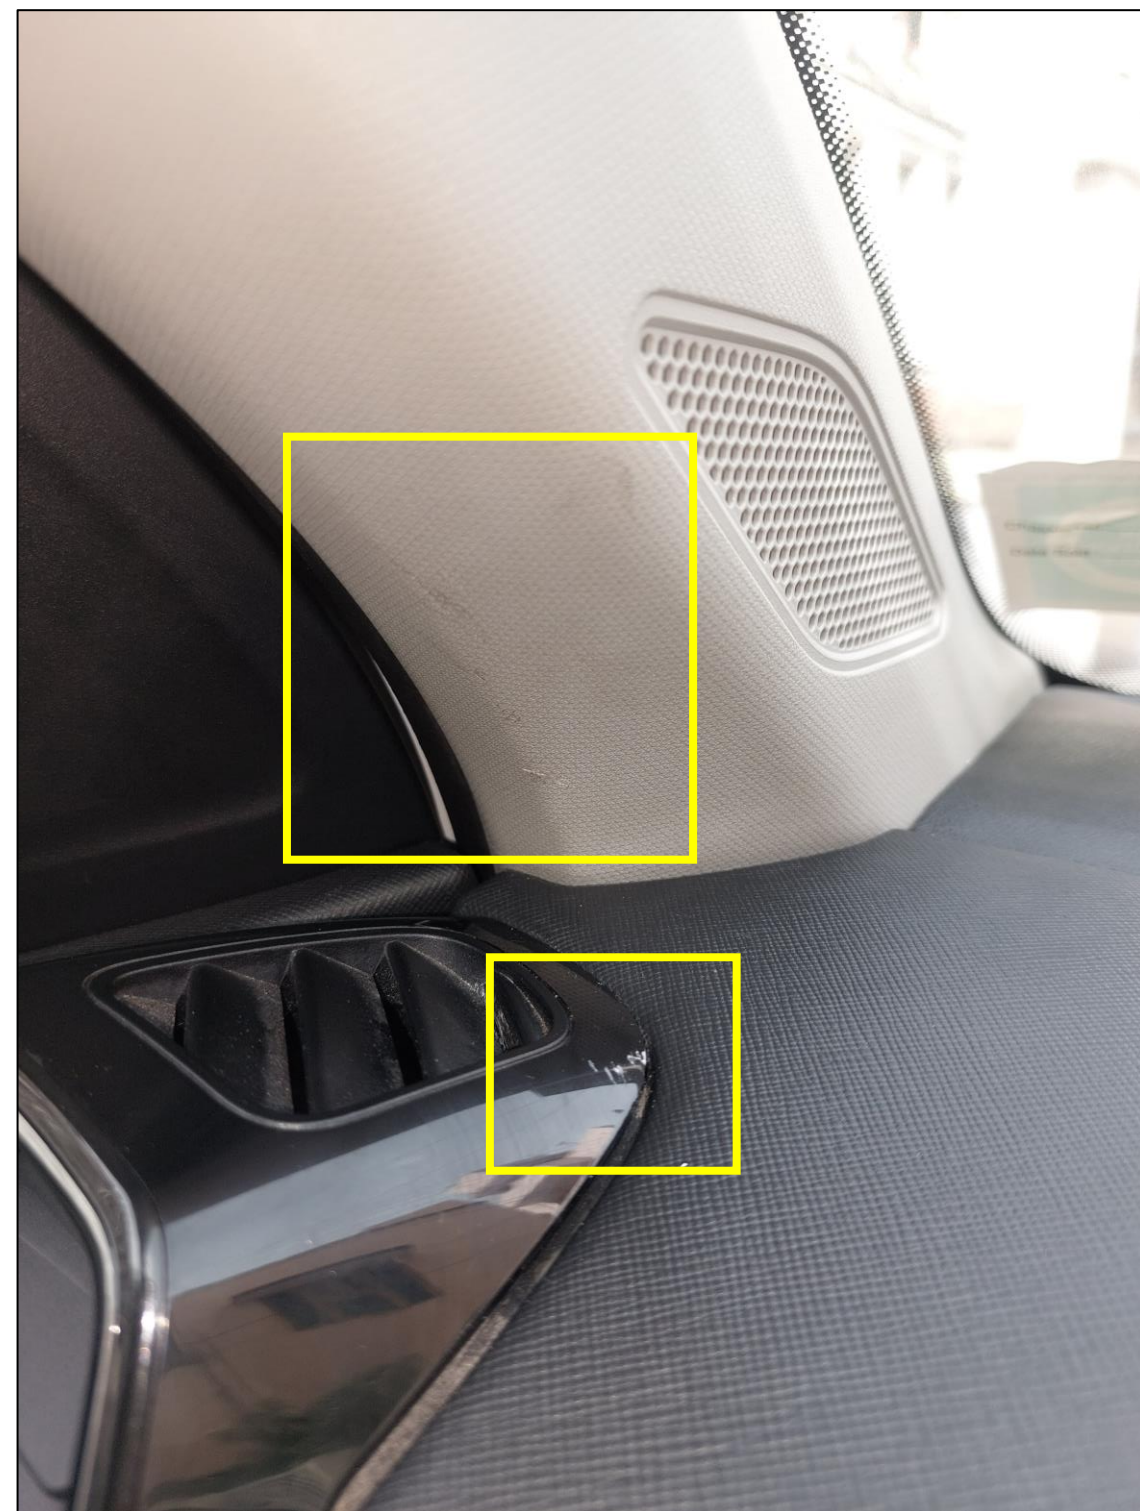
Damage to A-Pillar plastic trim. Probably due to bad handling, storage and assembly.

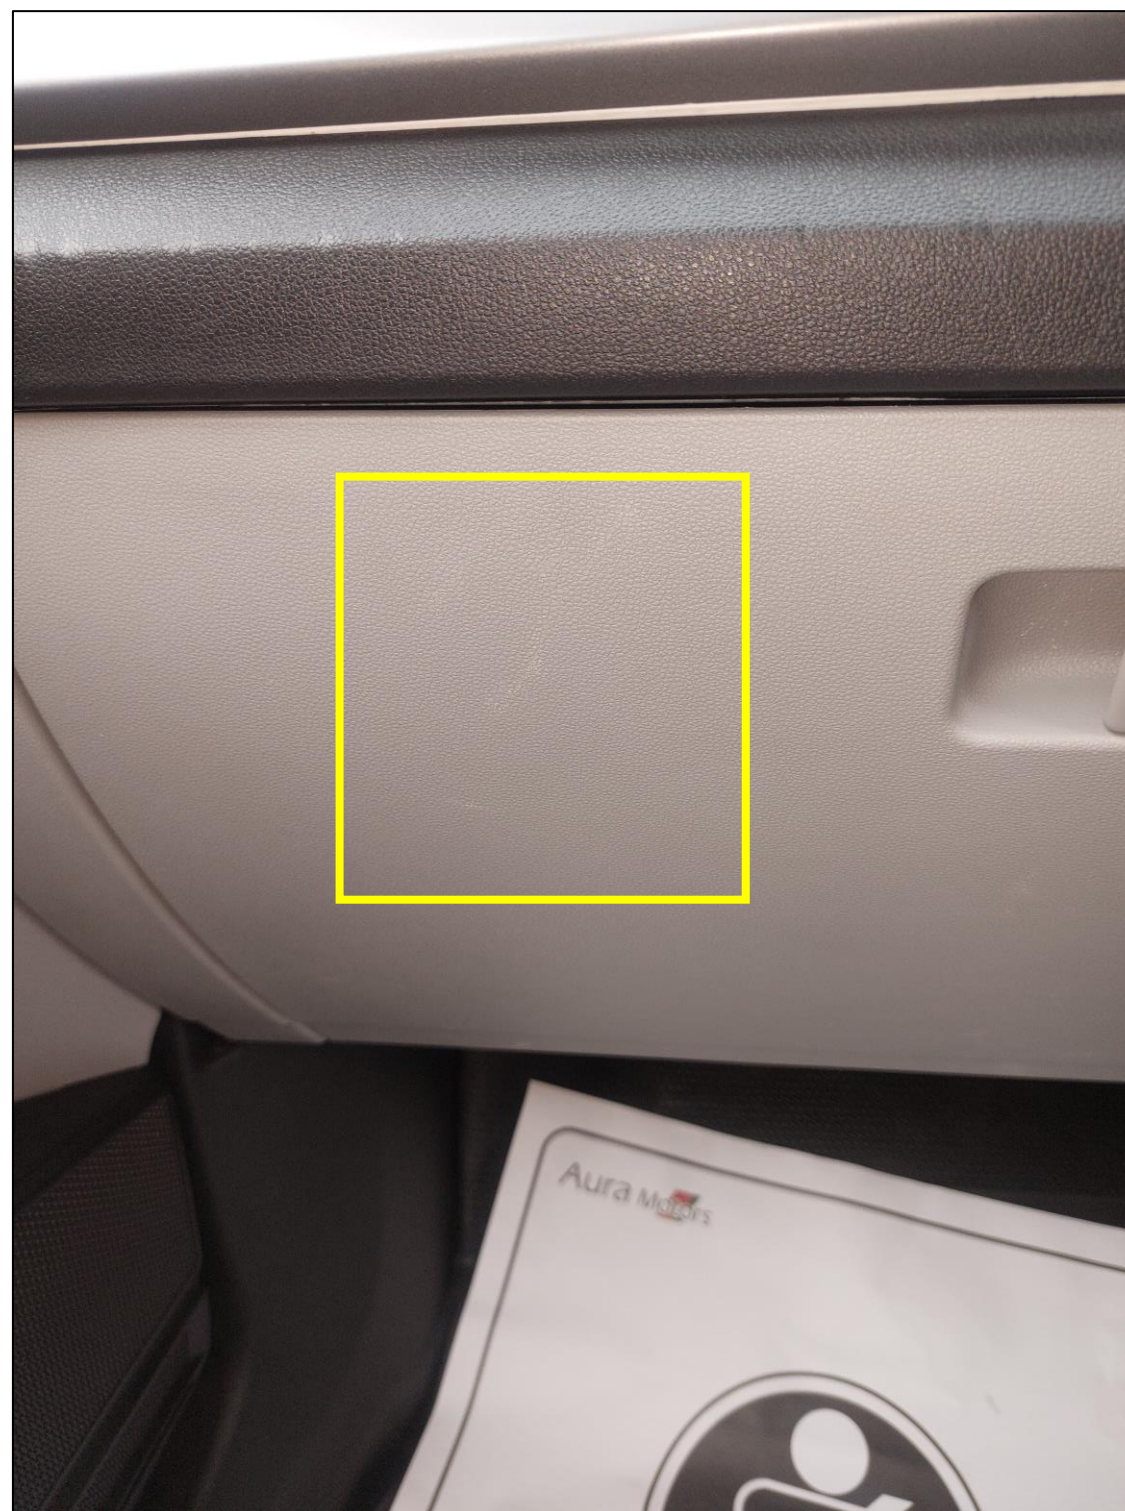
Damage to glove box
