Technical product information

Transaction No.: **2033456/1**

1.6l CR Injectors_Electrical fault

Release date: 28-Mar-2013

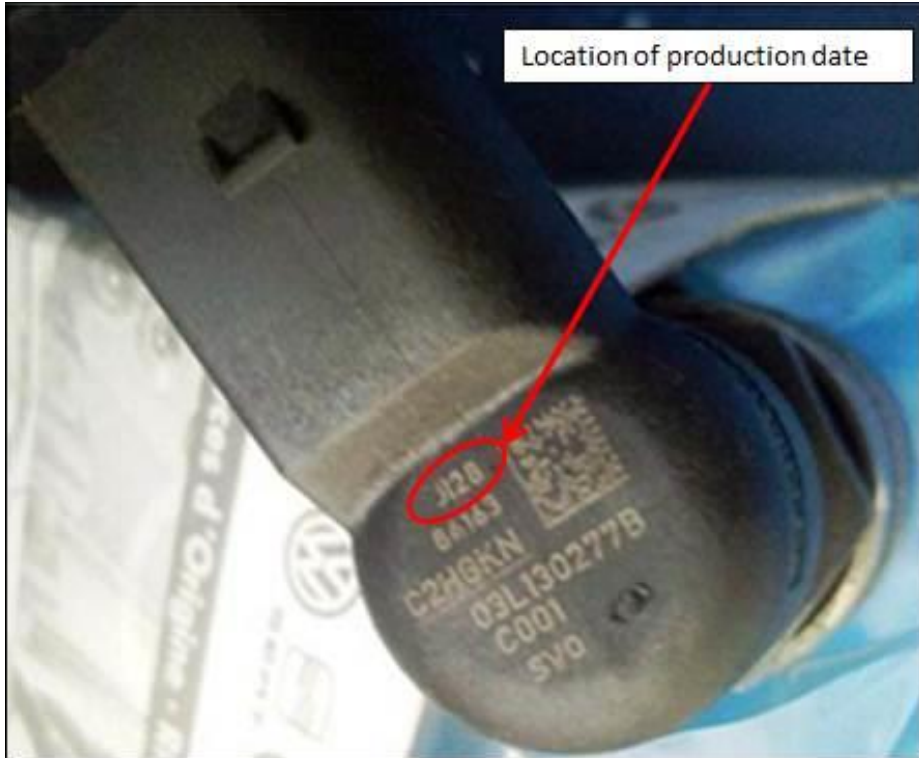
In the event of above faults observed in diagnostic log, Take pictures of faulty injector (which is recognised as an electrical fault in diagnostic log) as shown in below picture:

Check electrical connection of injector for loose contact & contact corrosion, if found then repair accordingly.

Defective injector must be replaced by improved injector as per following guidelines:

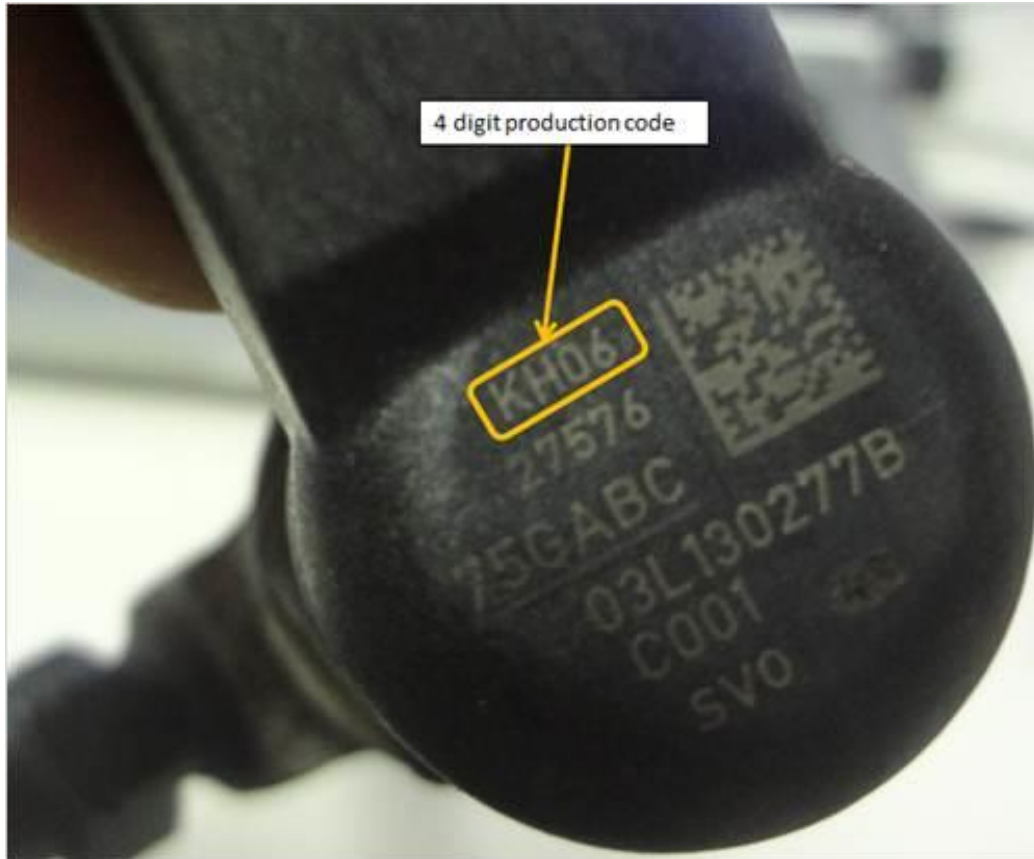
Please read four letter code on Injector e.g. KH06 (06th Aug 2011)

K – Year - 11th Letter of alphabet which stands for Calendar year – 2011

H – Month - 8th letter of alphabet which stands for Month – August

06 – Date - 06th day of month

All injectors which are produced after 15th Jun.2012 are improved & should be used for replacement of defective injectors.
