Everest Corrosion Repair Overview

Background

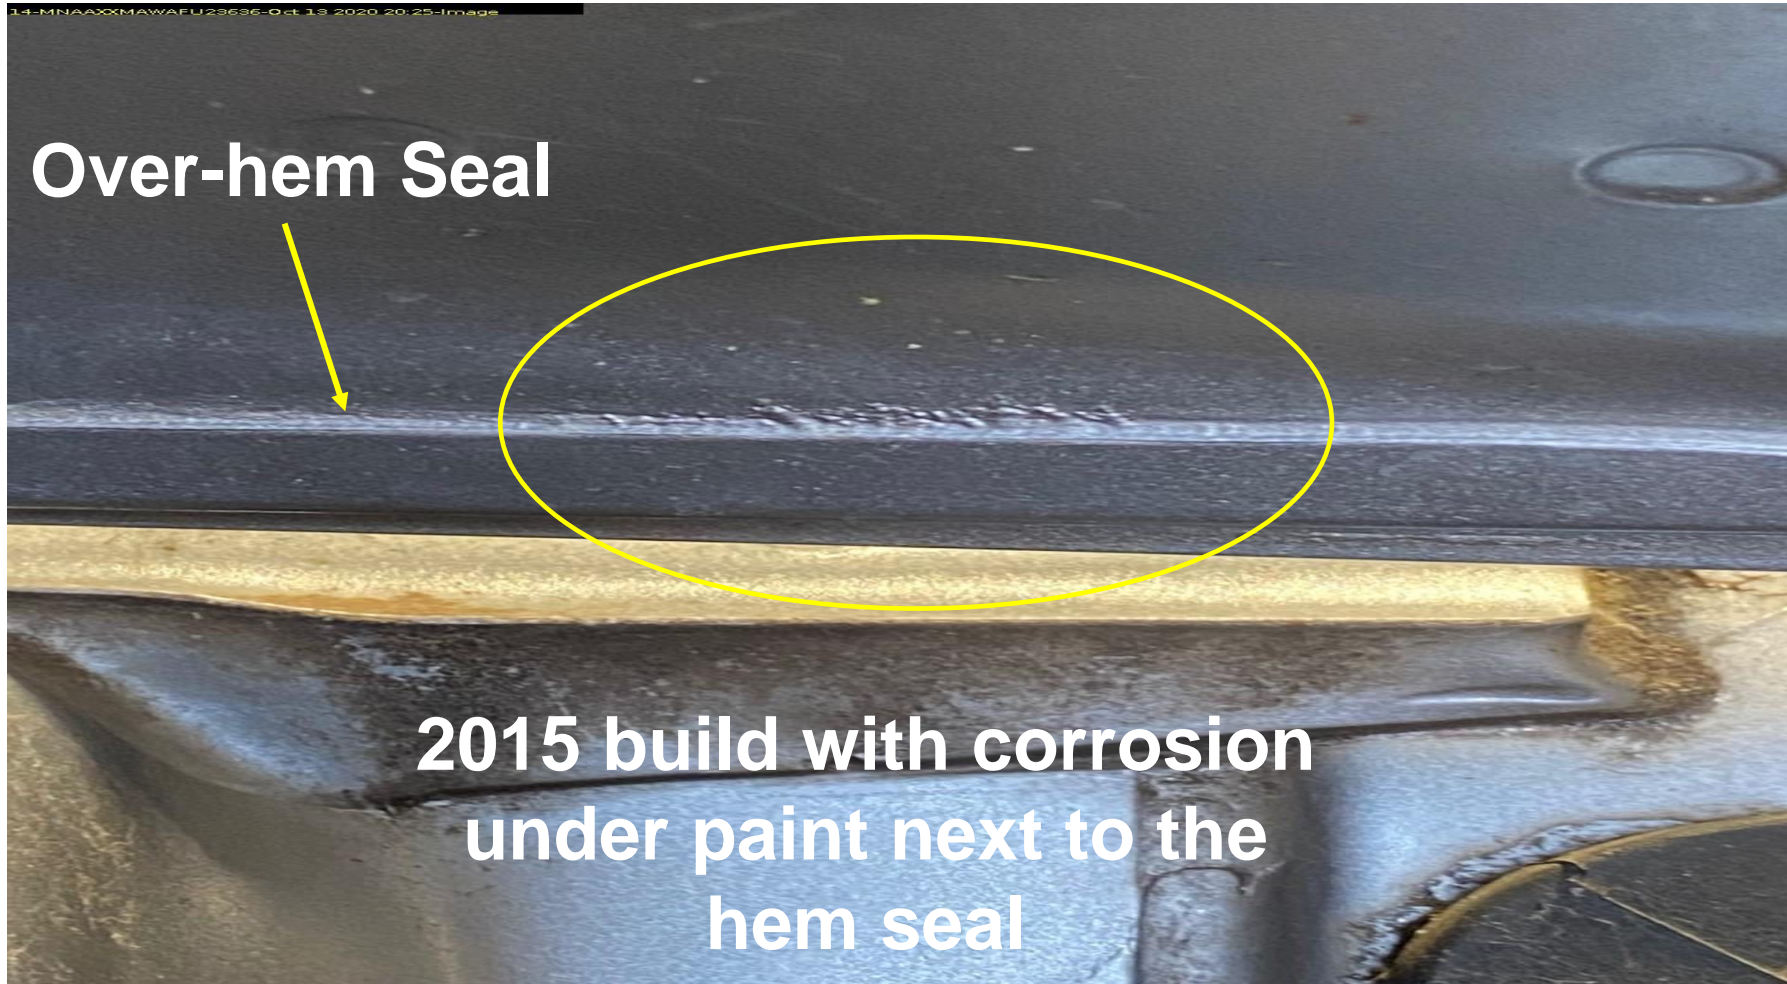
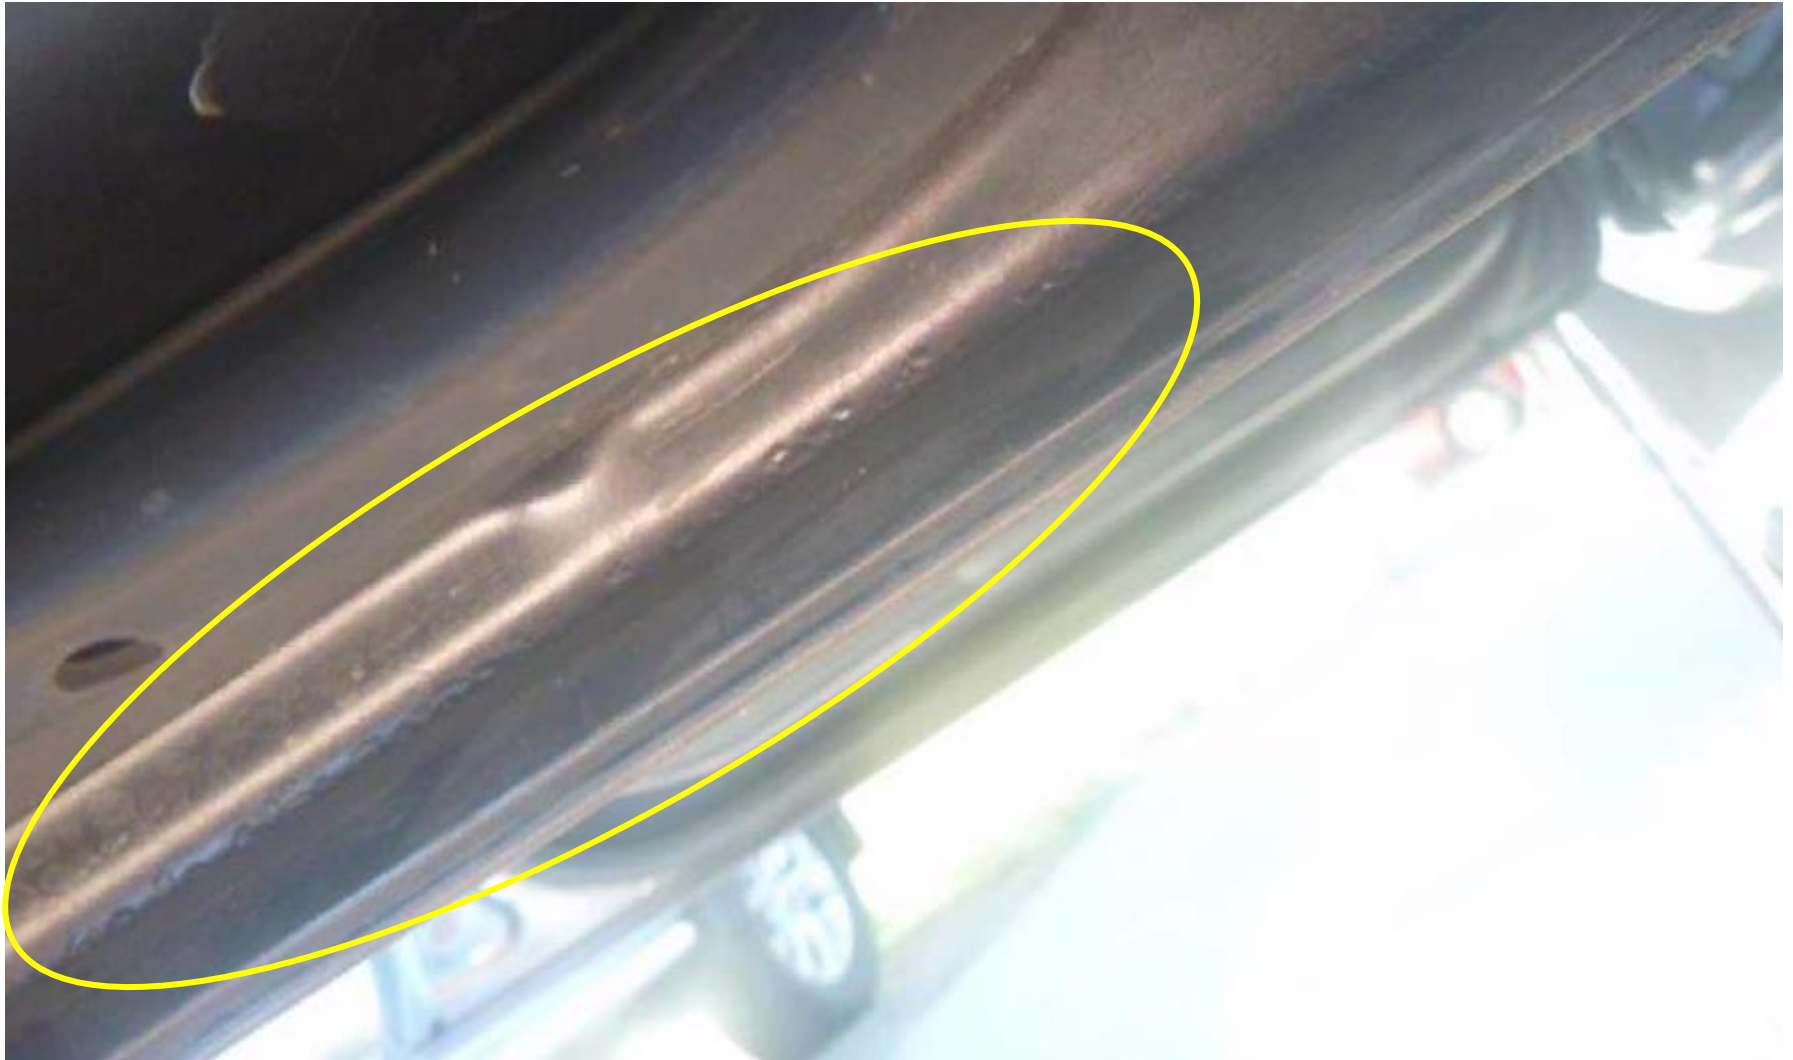
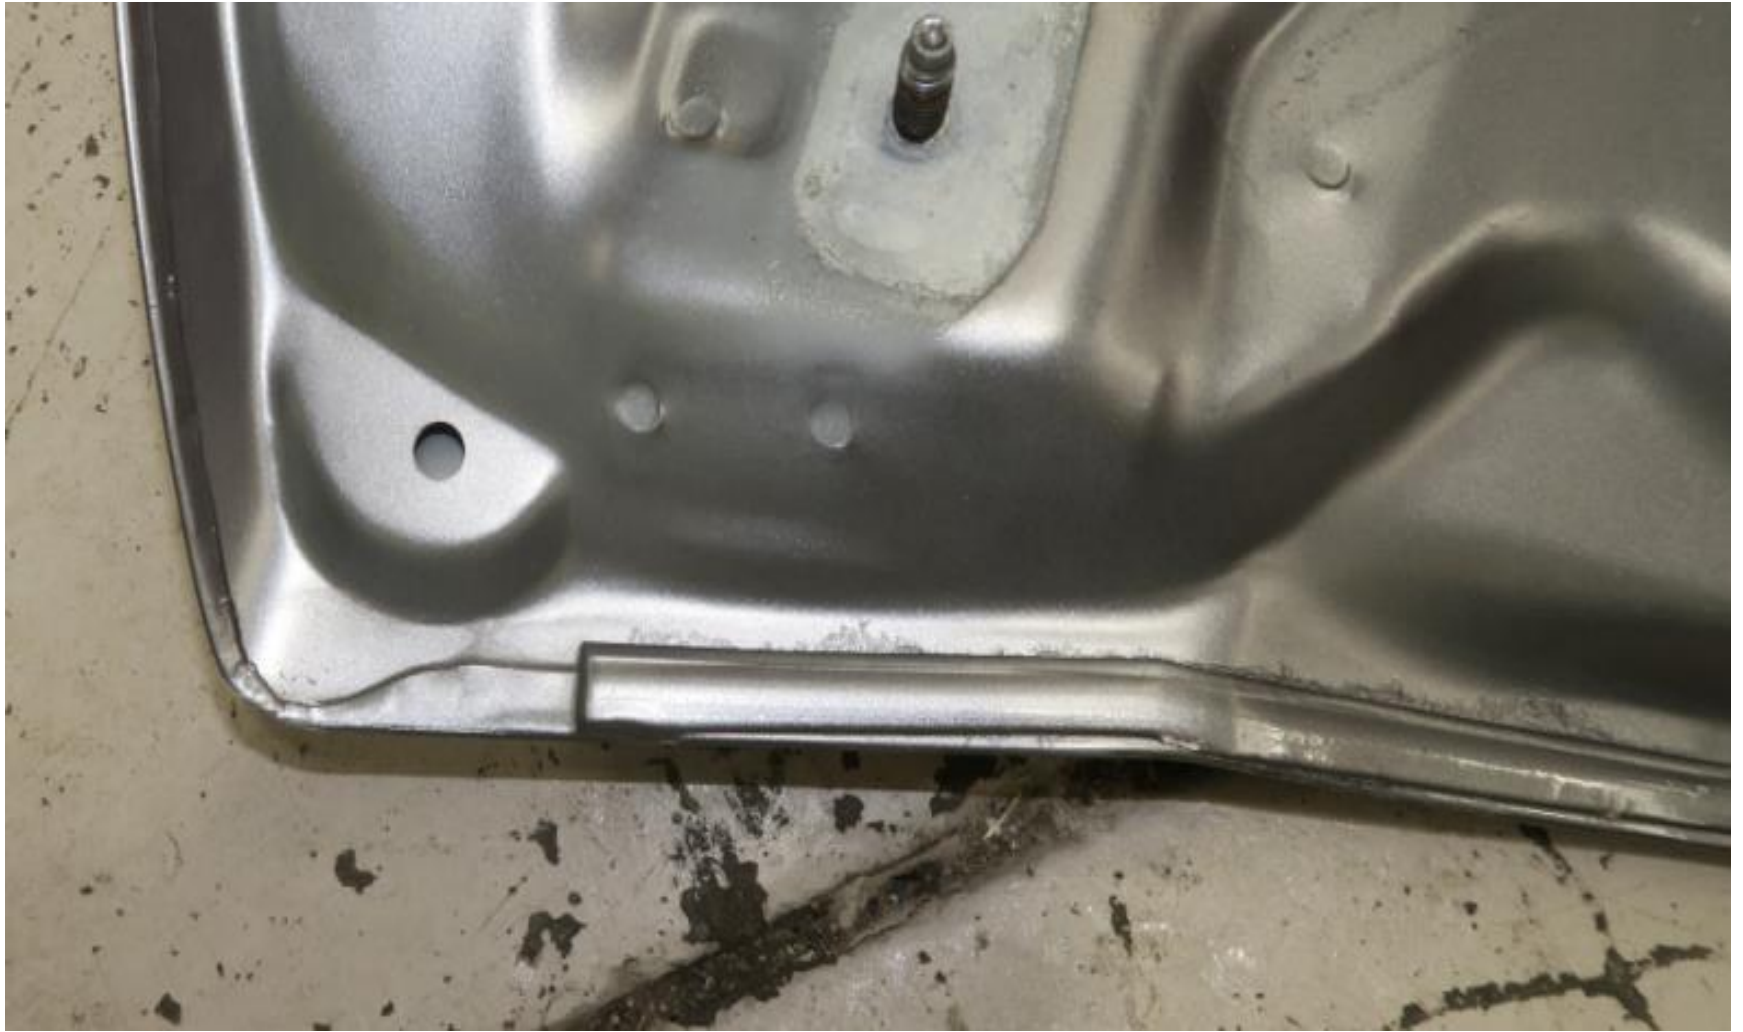
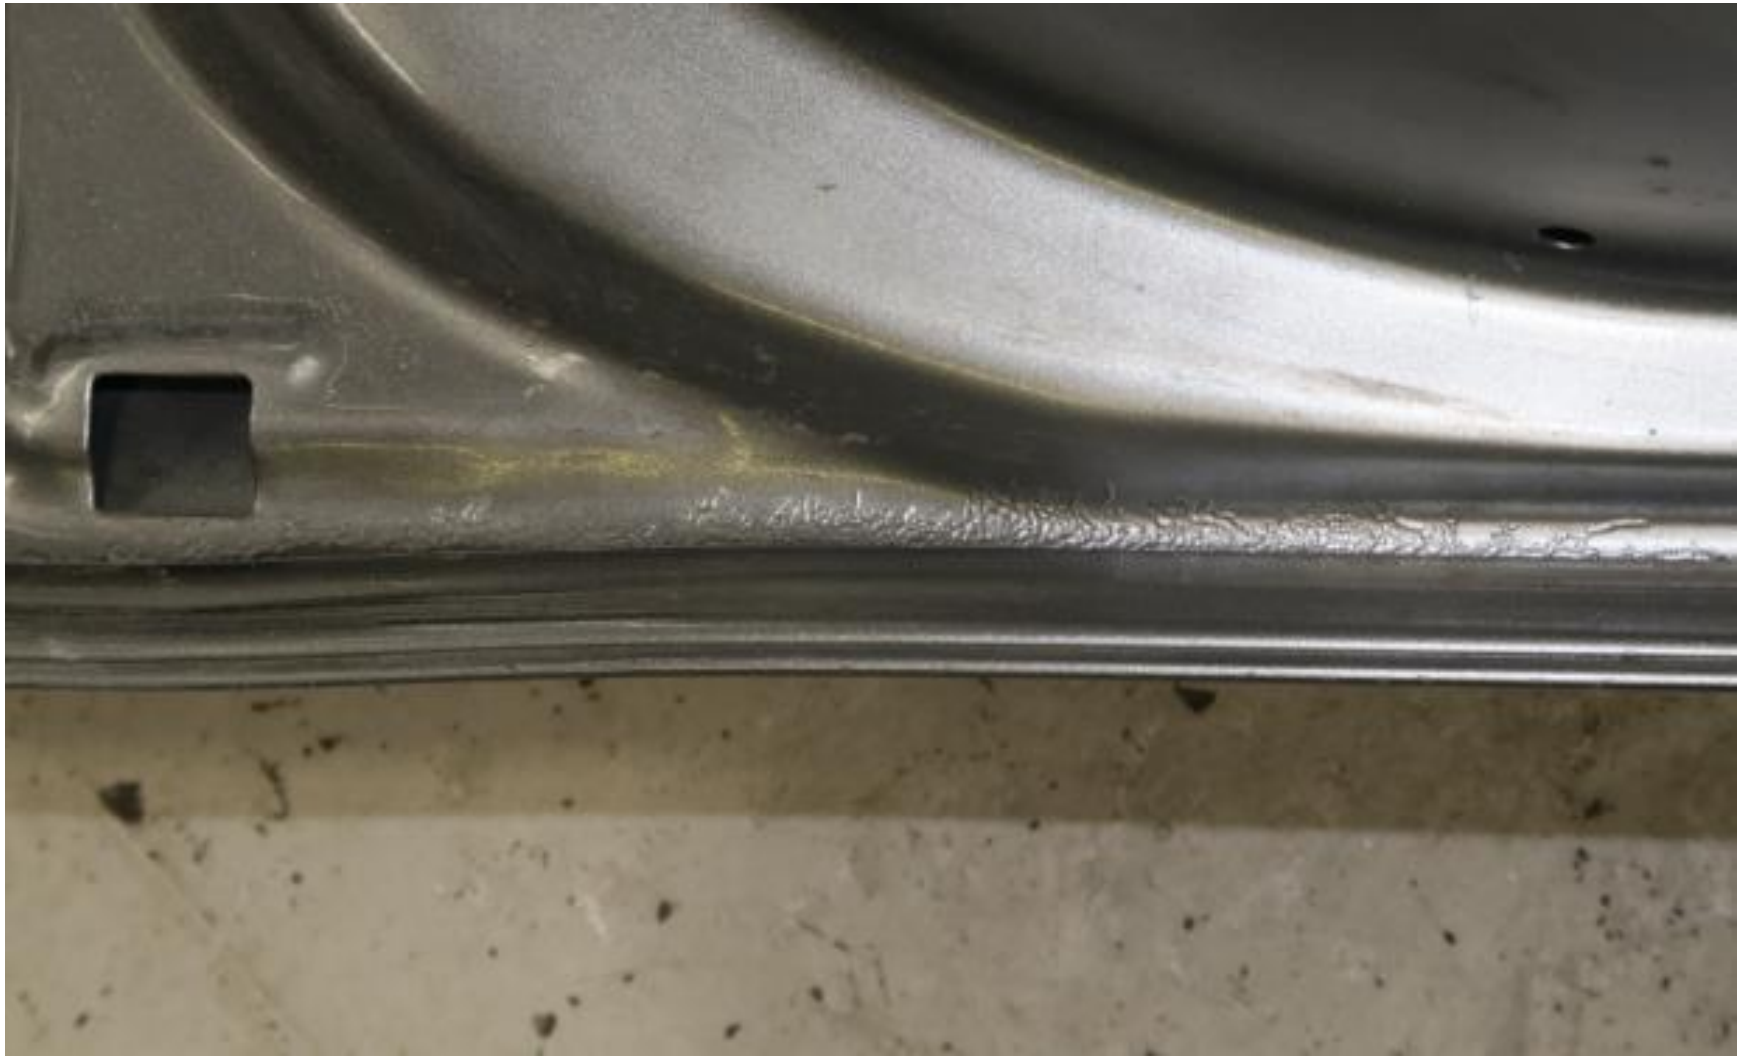
Images of Affected Panels

- Certain Everest vehicles have been identified with visible signs of corrosion in closure panels
- Corrosion has been identified in some doors, hoods and liftgates where insufficient seam sealer has been applied in the manufacturing process. The issue does not relate to all panels
- Repair process will be to replace / paint new panels
- Build period identified from Job 1 (2015) up till September 2018 (containment action introduced)
- Repair process under investigation are:
 - 4 door replacements - Requires Service Kit comprising of all 4 doors
 - All panel replacements - Requires Service Kit comprising of all 4 doors, plus hood and liftgate
- Program is likely to cover up to 10 years in service
- Analysis indicates expected volume is likely to be around 1,300 vehicles Nationally

- Rectification on affected Ford Everest vehicles following an agreed repair process provided by Ford
- Fixed cost per variant e.g. 4 doors only / 4 doors plus hood and liftgate / clear over base / metallic.
- Specified time to repair affected vehicle variants (vehicle off-road time)
- Establish and maintain a data base showing vehicles that have been repaired, which repairer carried out the repair and the date it was repaired.
- Centralised management of all repairers
- Customer handling process to be consistent Nationally across all repairers, locations, variants, Dealers, etc.
- All vehicle parts to be supplied from local Ford Dealership

- Includes items such as:
 - Pick up and return vehicle to Dealership
 - Remove and refit panels and necessary components
 - Transfer all parts from affected panel to new panels
 - Fit sound deadening pads as indicated in Ford specification
 - Replace and align panels
 - Seam seal all doors to original factory finish prior to painting
 - Paint preparation and colour matching as required
 - Refinish (paint and blend) to OE finish
 - Wash & clean the vehicle after repairs completed
