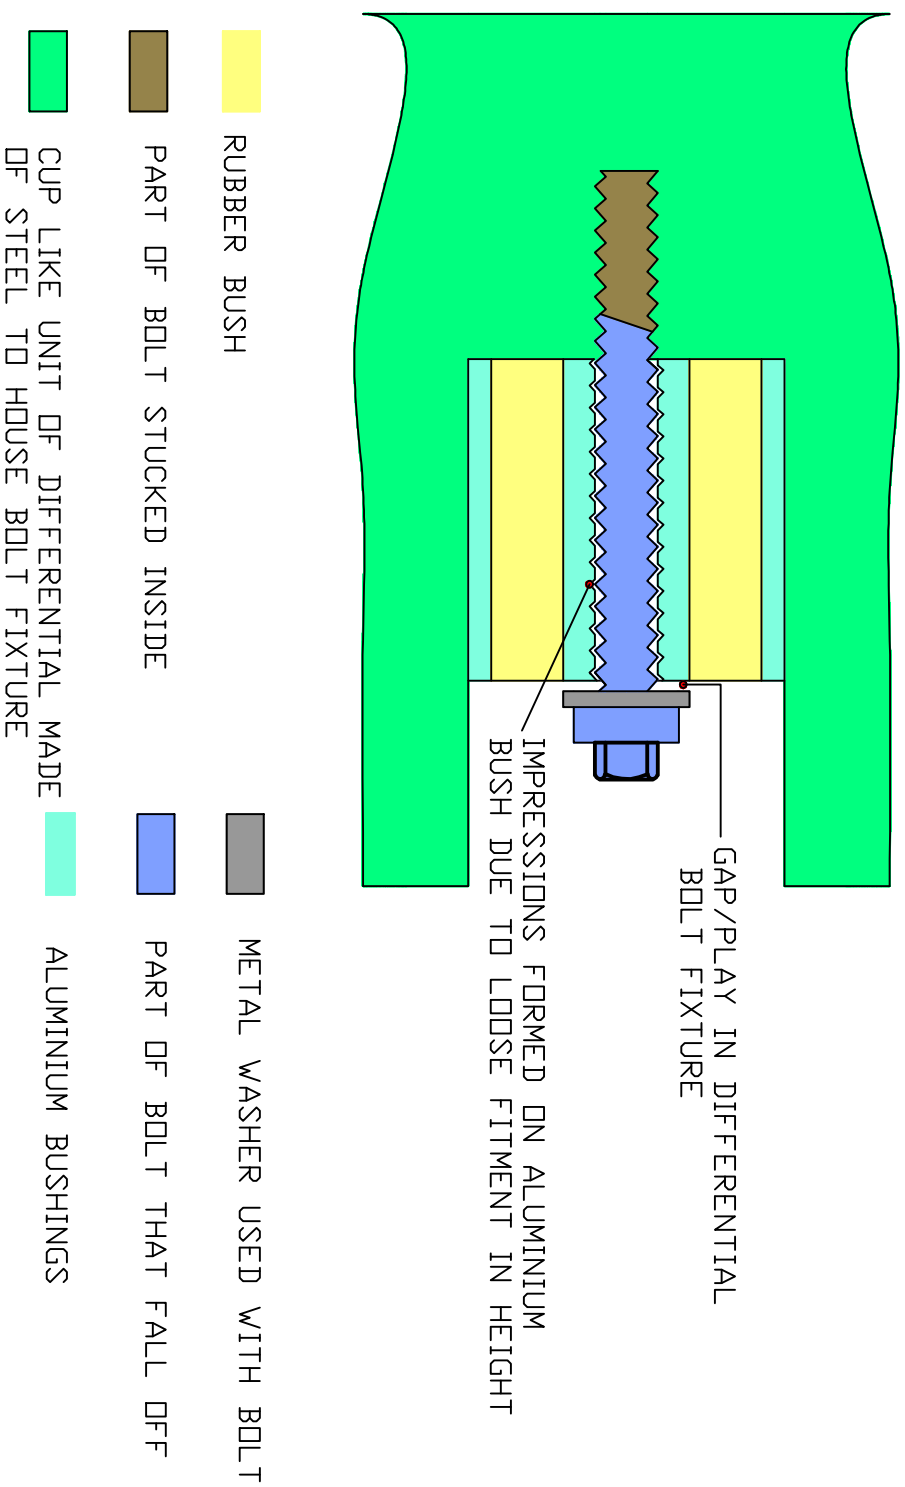
THE PLAY/THE GAP LEFT IN THE FIXING OF THE BOLT LED TO THE VIBRATION OF THE HARDENED RUBBER BUSH WHICH BRUSHED AGAINST THE BOLT CAUSING WEAR & TEAR (SHEARING) OF THE BOLT. EVENTUALLY, THE BOLT CRACKED.
