Technical Service Handbook

Model description: **POLO A05 Ind.TREND 77 TDI M5F**

Technical product information

Noise from front side of the car

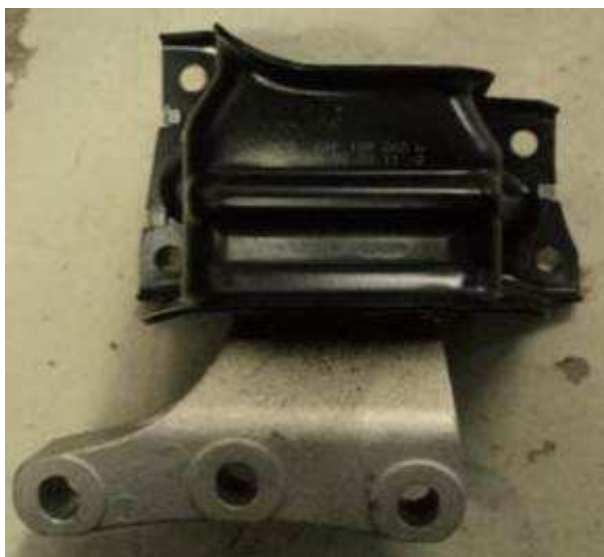
Significant gap between bonded rubber & bracket resulting into axial play of engine during startup & dynamic condition of the car. Hence abnormal rattling noise is heard from engine compartment.

Picture 1 – Bonded rubber mount

Once the abnormal rattling noise from engine compartment is confirmed due to engine mount (A mount) then replace bonded rubber mount (See picture 1) by hydraulic rubber mount (See picture 2) as per the part numbers given below based on engine variant.

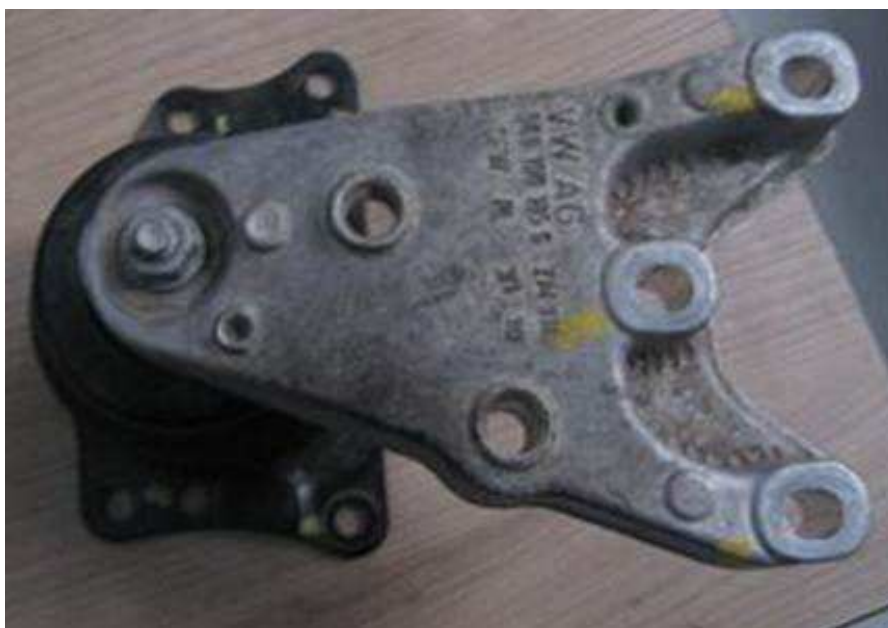
Picture 2 – Hydraulic rubber mount

Sr.No.	Engine variant	Part No. (Hydraulic Rubber Mount)
1	1.2l, 55 kW, MPI (MT)	6R0.199.167.AA
2	1.2l, 55 kW, CR (MT)	6R0.199.167.R
3	1.6l, 77 kW, MPI (MT, AT)	6R0.199.167.Q
4	1.6l, 77 kW, CR (MT)	6R0.199.167.E
