M&M Xylo E6 (2010) – Engine Bay : Alternator Regulator & Brush Assy replace

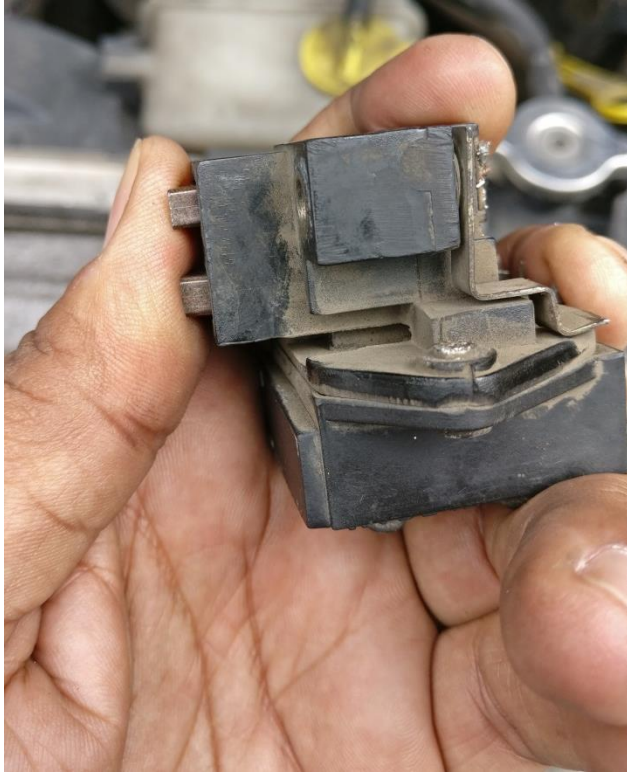
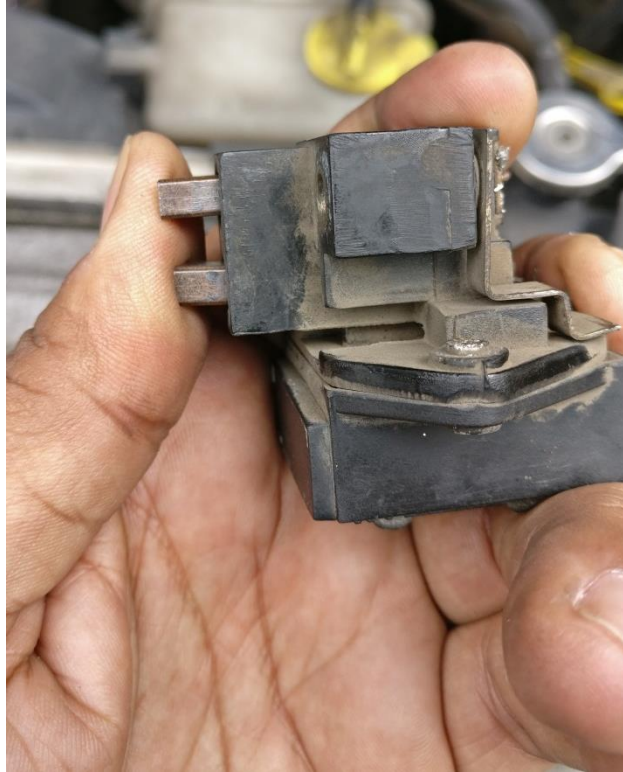
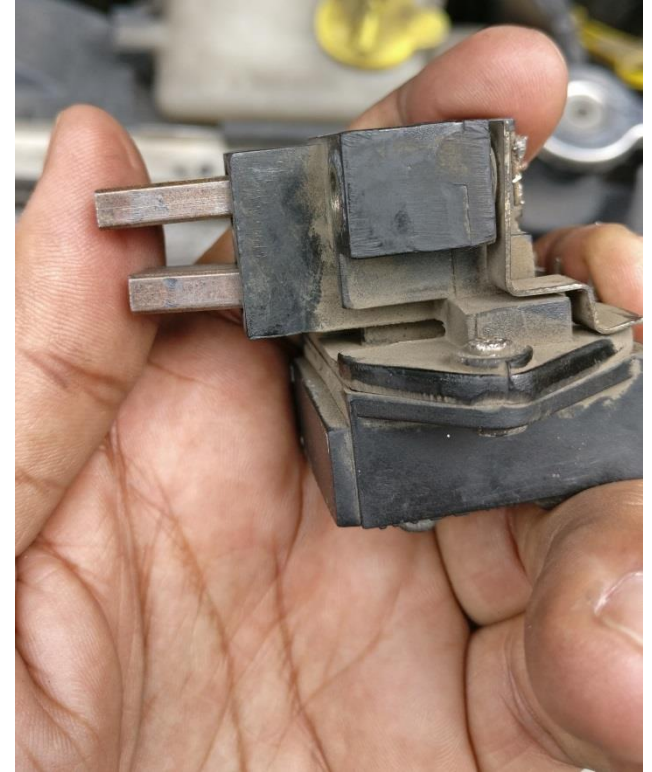
In normal operation, within the alternator system, these carbon brushes will keep rubbing (contacting) the coil underneath, in a spring manner. Over the years, these carbon brushes could get worn-out, which result in poor charging of battery and other electrical functions of the vehicle.

- Basic workaround: the install newer carbon brushes
- Ideal solution: get the Regulator assembly changed (comes with new brushes)

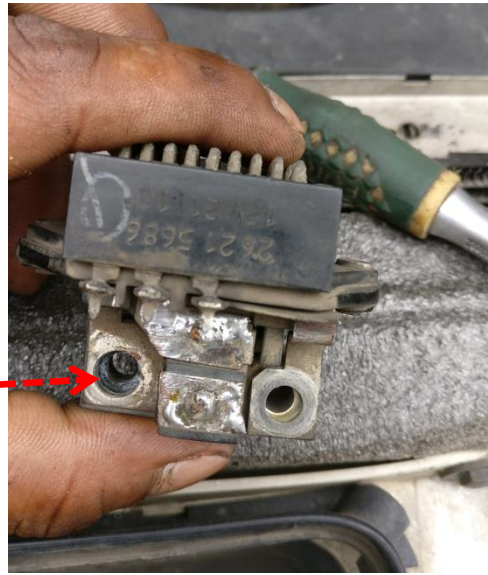
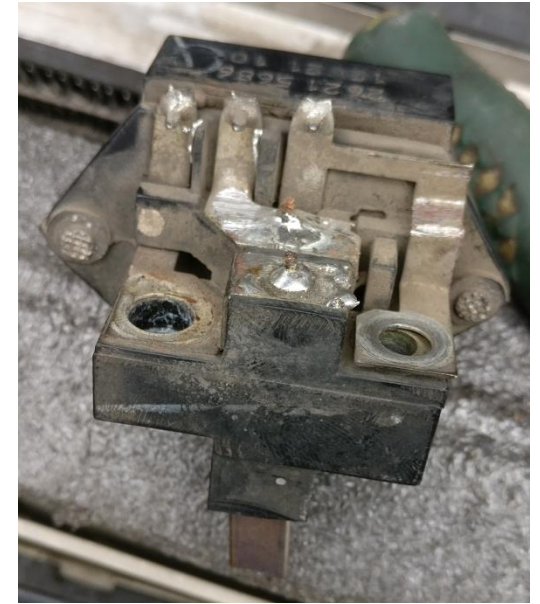
New Carbon Brushes fixed

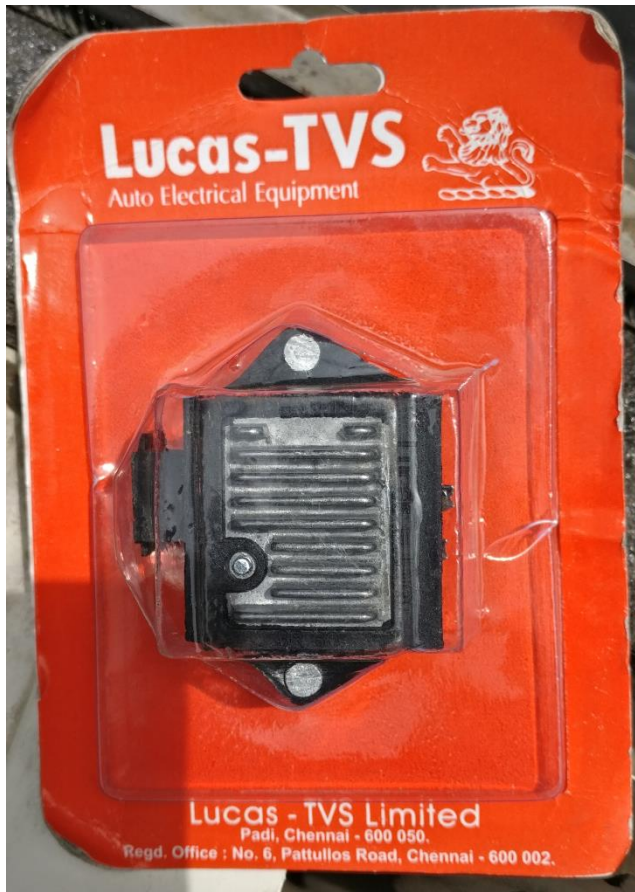
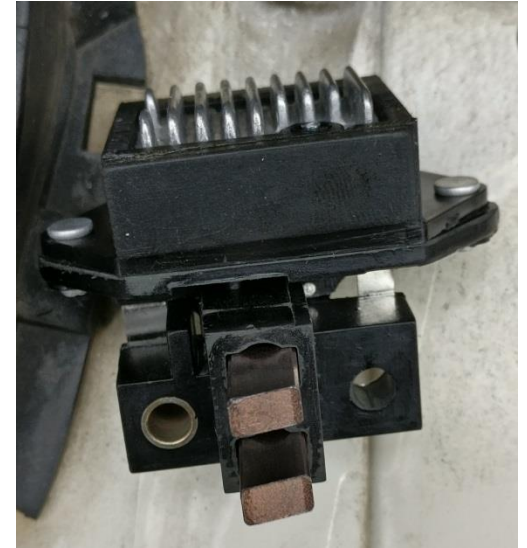
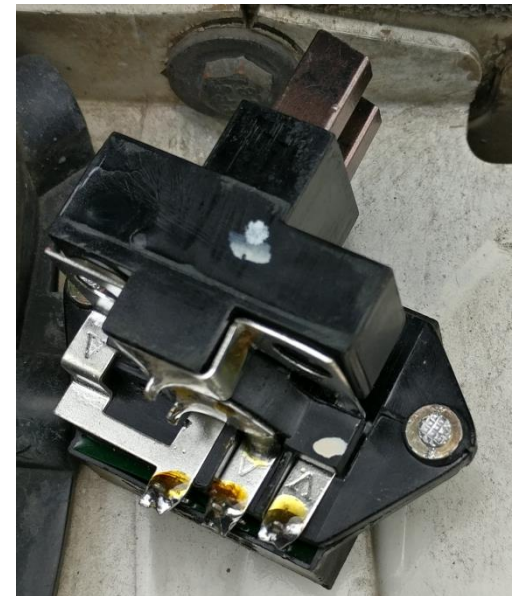
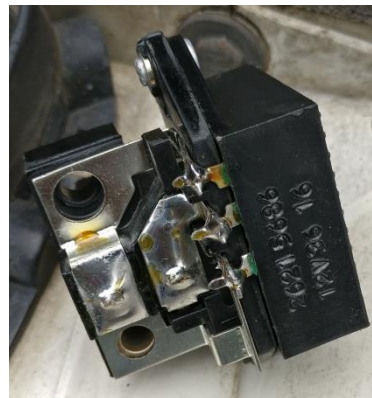
New Regulator Assembly

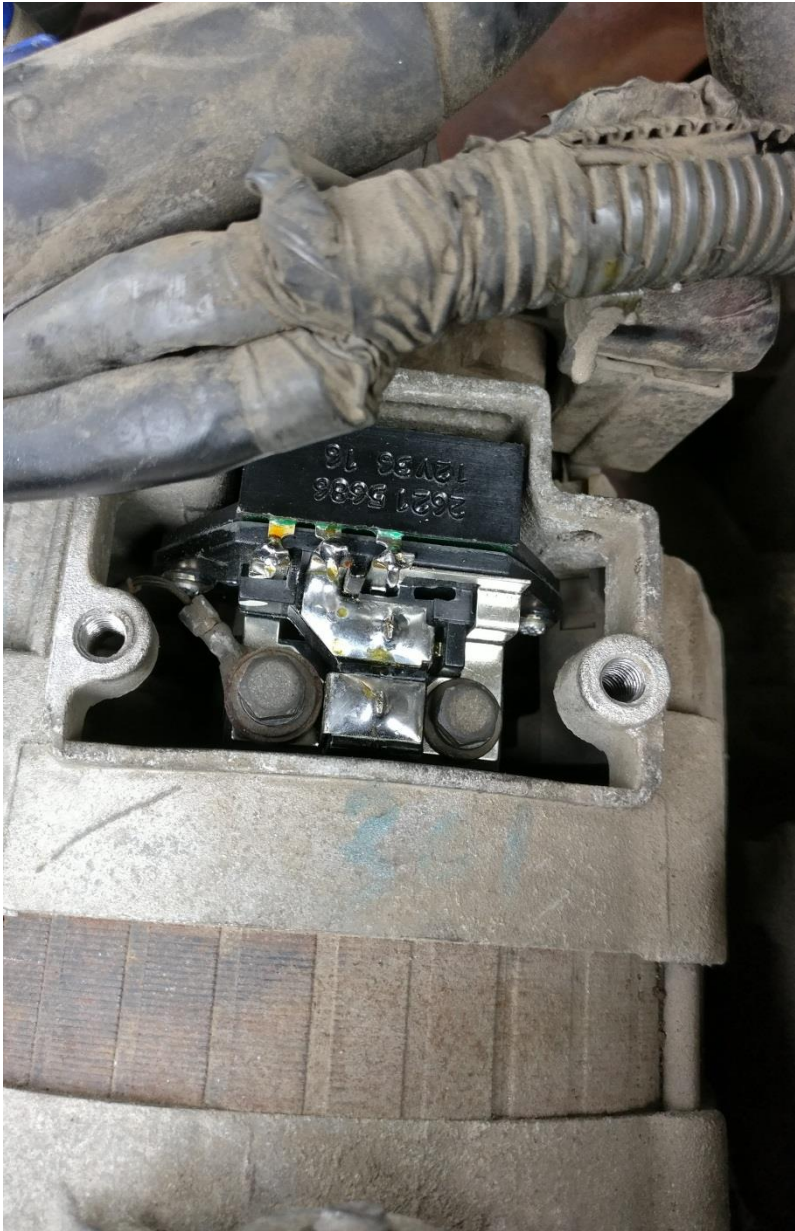
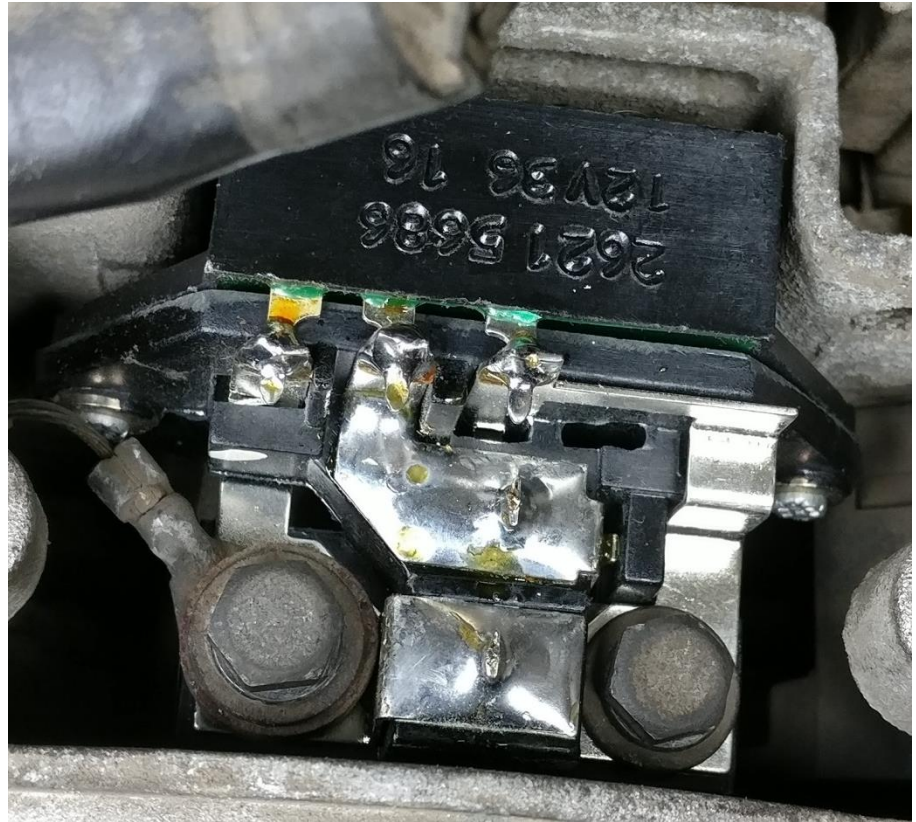
Installed the new Regulator Assembly
