Vehicle Pulling to LH diagnosis & repair

Fiat Models Linea and Punto versions

AS/SN/Mar/15/86

Handling of vehicle pulling and rear tyre wear complaints in Linea & Punto

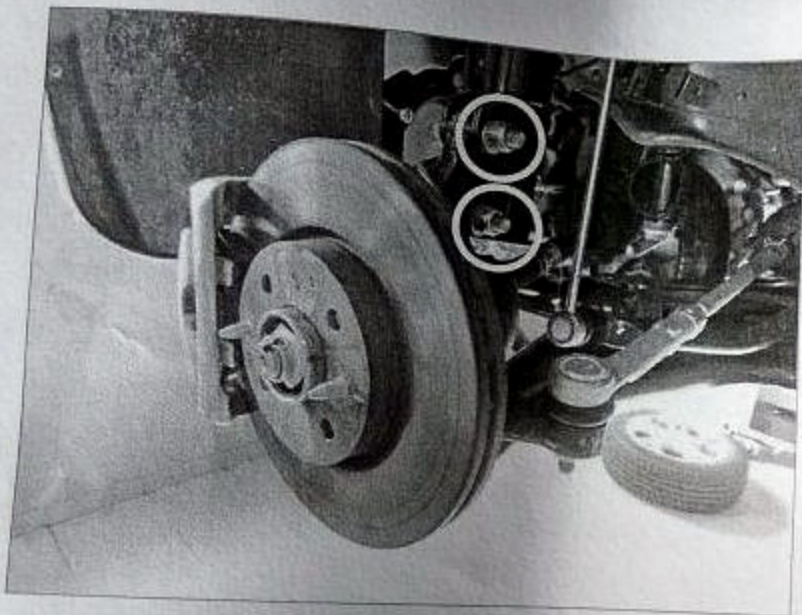
LH Knuckle

- ❑ Carry out the wheel alignment to note down the deviation in values.
- ❑ Loosen the front both side knuckle Nuts by five-six threads

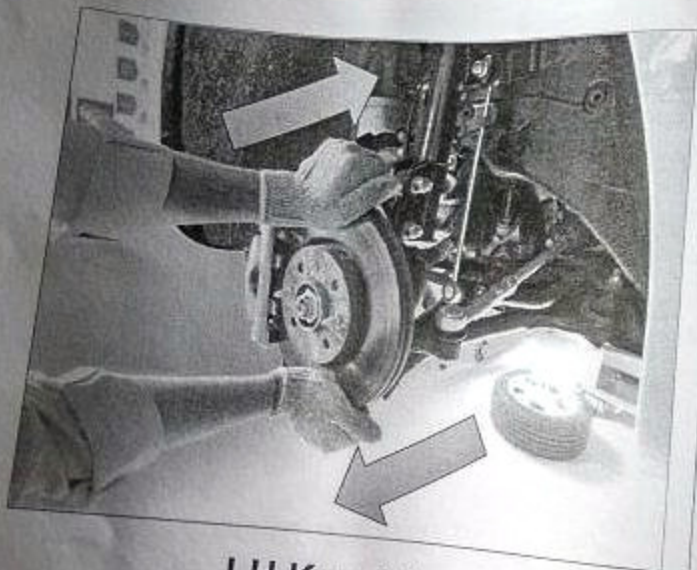
LH Knuckle

- ❑ Pull the Knuckle in the direction shown
- ❑ While pulling / pushing the knuckle in the direction shown, simultaneously tighten the knuckle bolts with the help of another technician
- ❑ Torque tighten the nuts to 100 Nm

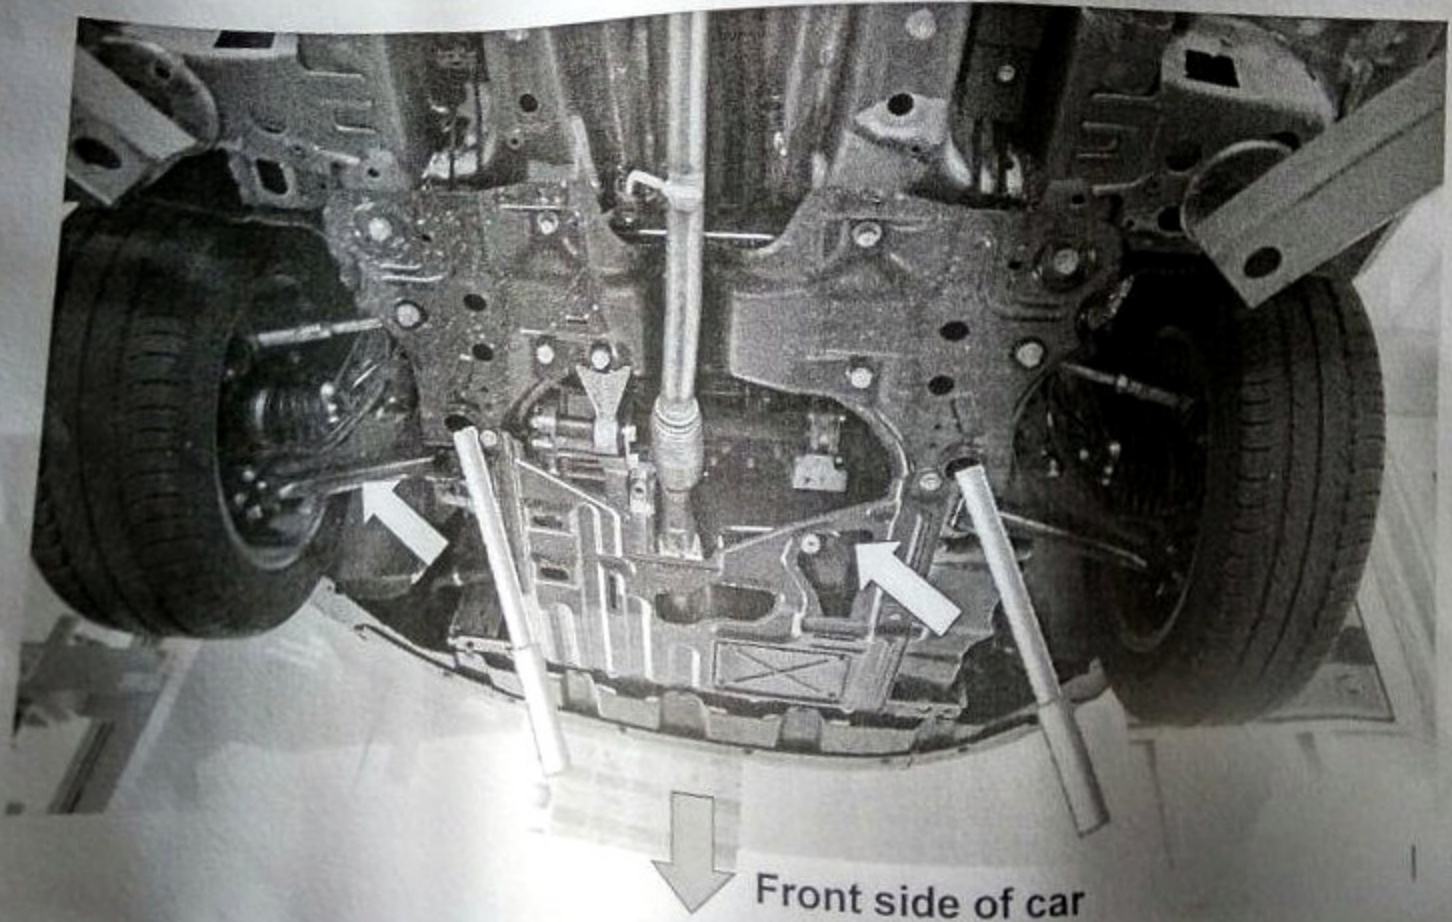
Step-2

- ❑ Diagonally Push the sub frame with pry bars to the left side in the direction shown
- ❑ While simultaneously pushing the sub frame in the direction from two places, tighten the sub frame bolts with the help of another technician
- ❑ Torque tighten the bolts to 125- 130 Nm

Note : Do not use pneumatic gun for tightening the bolts.

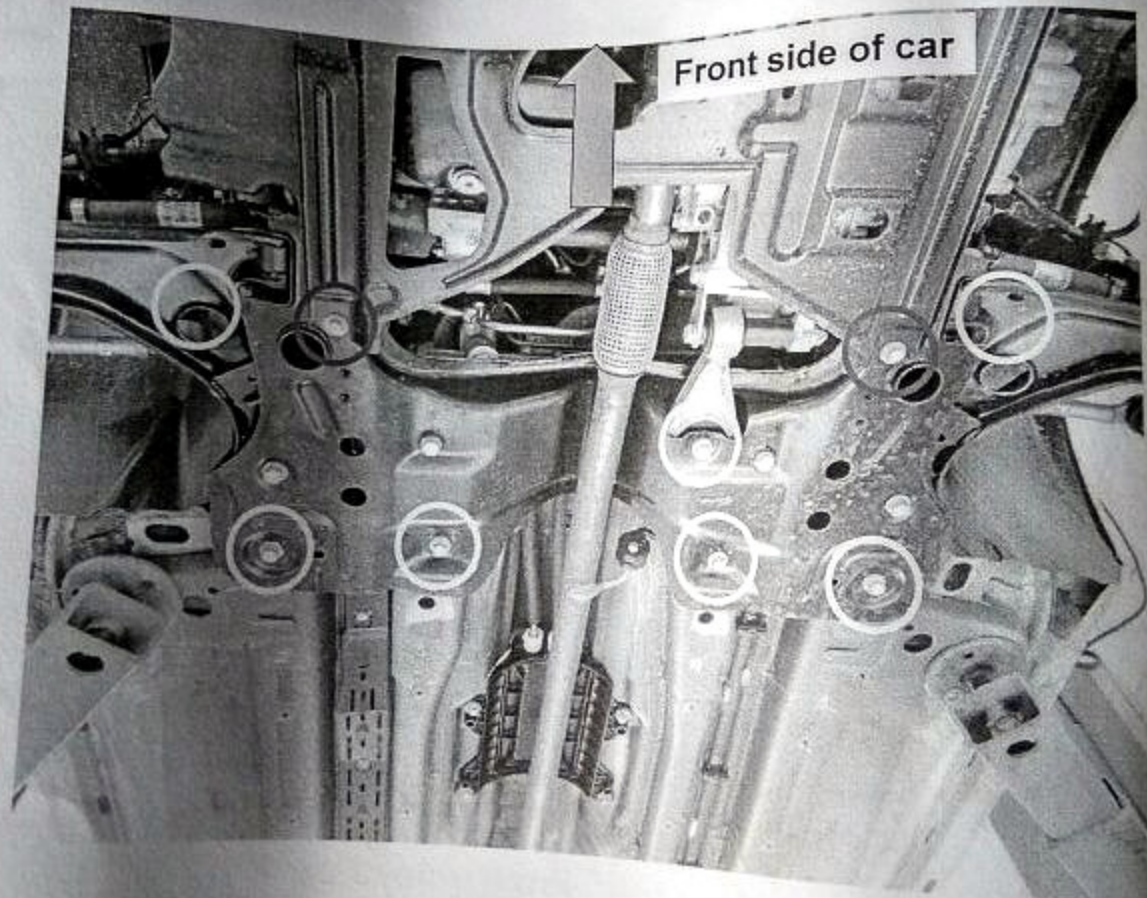
Step-2

- Loosen the sub frame bolts & C mounting bolts (marked yellow) by five-six threads
- Loosen the under shield bolts (marked blue) by five-six threads.

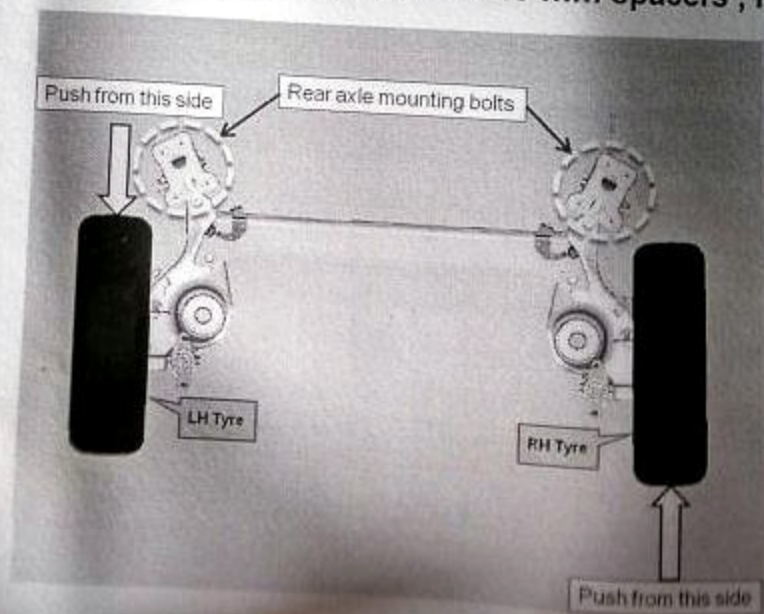
Step-3

Procedure of adjusting rear axle

- ❑ Lift the vehicle in a hoist
- ❑ Loosen the Rear axle mounting bolts by five to six threads
- ❑ Adjust the rear axle as shown in the fig, While keeping the axle pushed in the direction shown, tighten the rear axle bolts with the help of another technician.
- ❑ **Rear Thrust angle Specification $0^{\circ}00'$ to $\pm 0^{\circ}03'$**
- ❑ Torque tighten the bolts to 100-110 Nm.

Note : If the axle is adjusted as per the as per step-3, the REAR RIGHT wheel toe-in should be corrected as per step-4 with 0.5 mm spacers , if not the tyre will wear out.

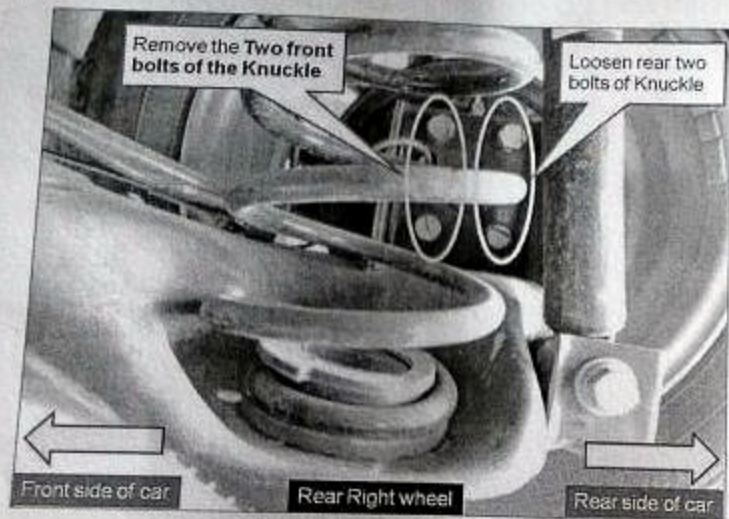
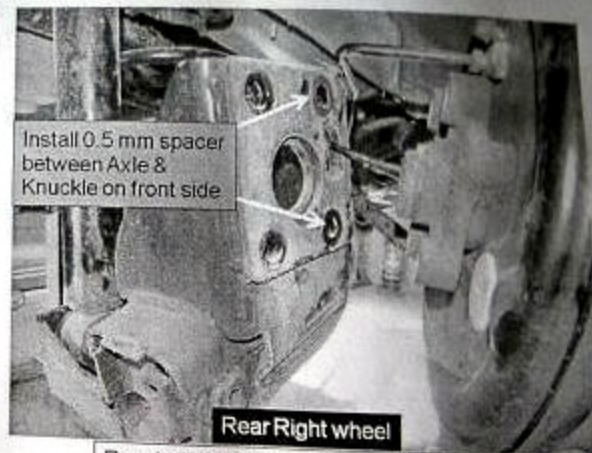
Step-4

Rear individual wheel Toe-in specification
0°08' to 0°24' or 0.7mm to 2.7 mm

Rear Right wheel toe-in correction

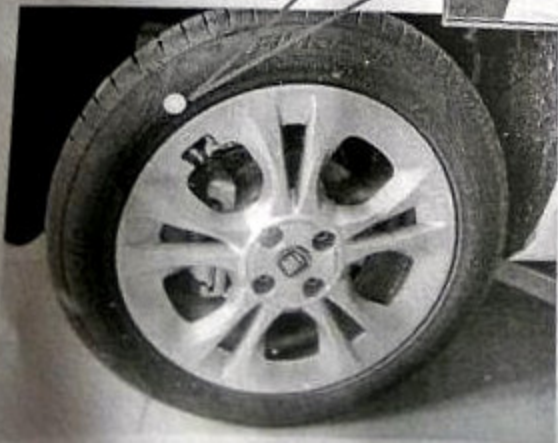
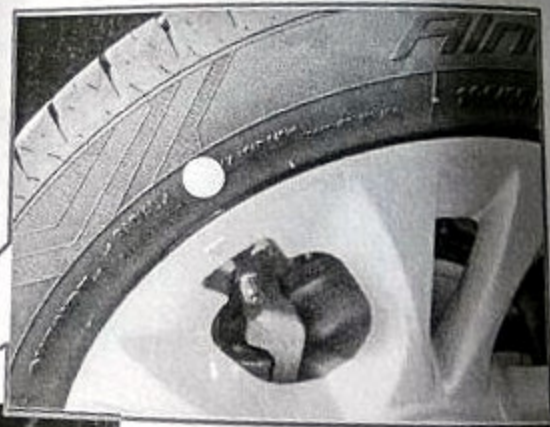
Step-5

- ❑ Change the face of the tyre inside out. Keep the yellow dot mark on the inner side (remove the front tyres from the wheel rim and flip the tyre inside out)
- ❑ Carry out wheel alignment
- ❑ Road test the vehicle.
