FINAL INVESTIGATION REPORT
ON ACCIDENT TO
JET AIRWAYS BOEING B-737-800 AIRCRAFT VT- JBG
AT GOA ON 27.12.2016

FINAL INVESTIGATION REPORT ON ACCIDENT TO JET AIRWAYS
BOEING B-737-800 AIRCRAFT VT- JBG AT GOA ON 27.12.2016

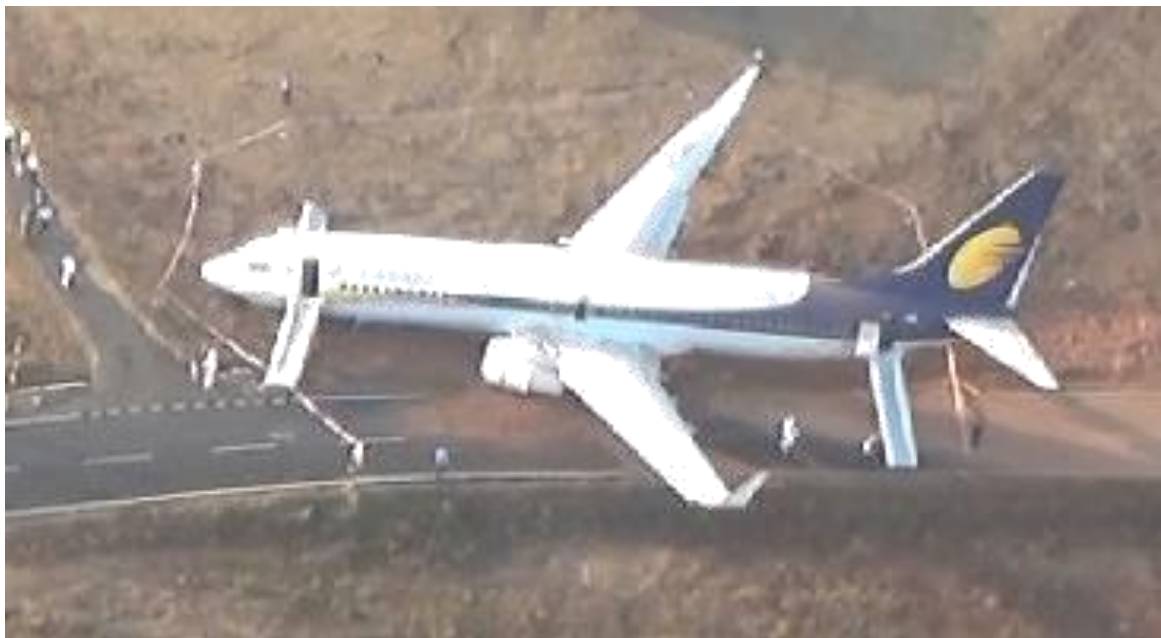
FINAL POSITION OF THE AIRCRAFT

At 22:39 UTC crew informed ATC of having evacuated all passengers. L1, L2, R1 and R2 cabin crew evacuated after evacuating all passengers, taking along the safety and medical kits. Co-pilot and subsequently Captain also evacuated the aircraft.
