**All BEFORE pictures were taken on 21<sup>st</sup> June 2023, before handing over car to workshop for replacing AC parts.**

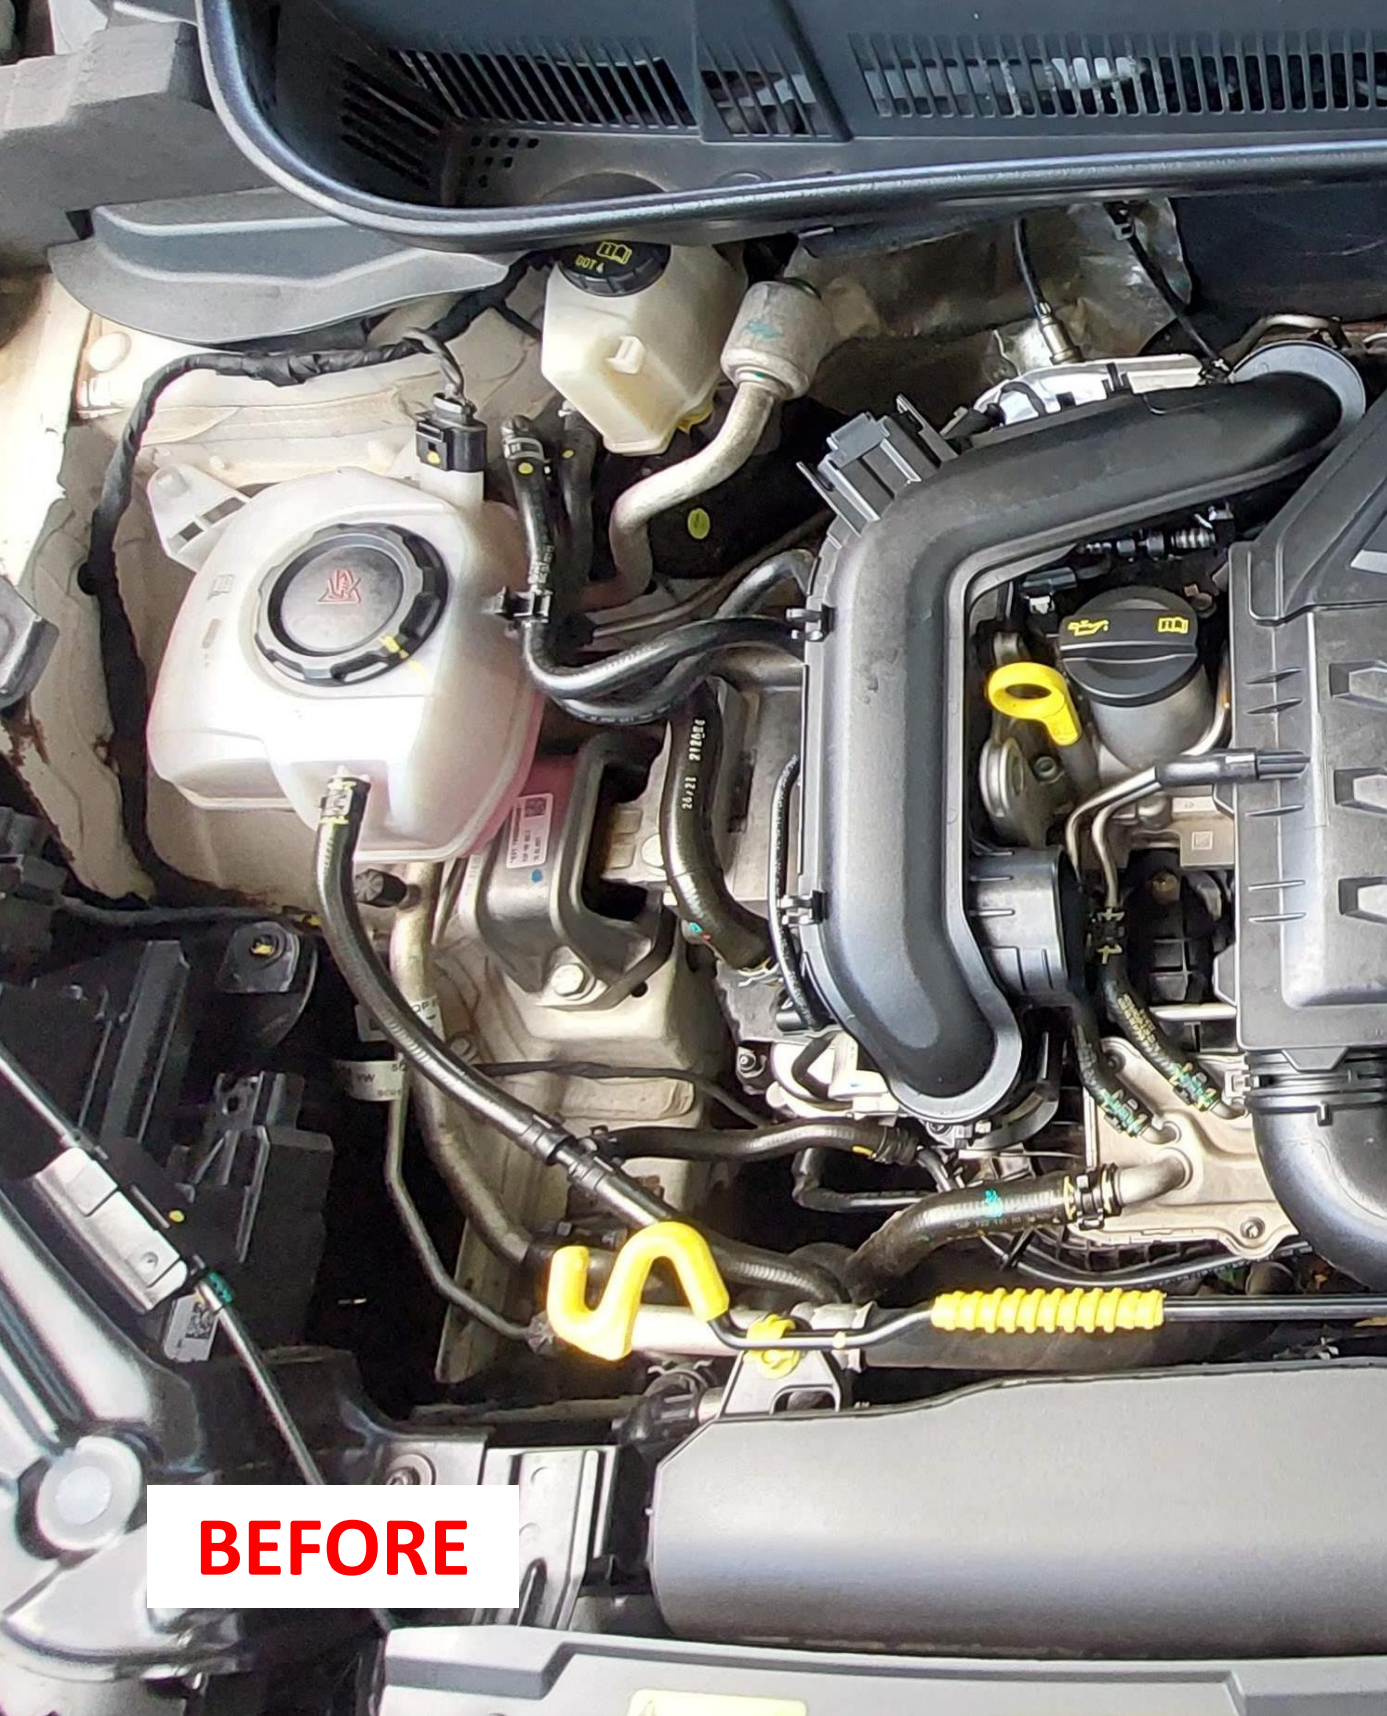
**Deep scratches in the full trim  
below infotainment**

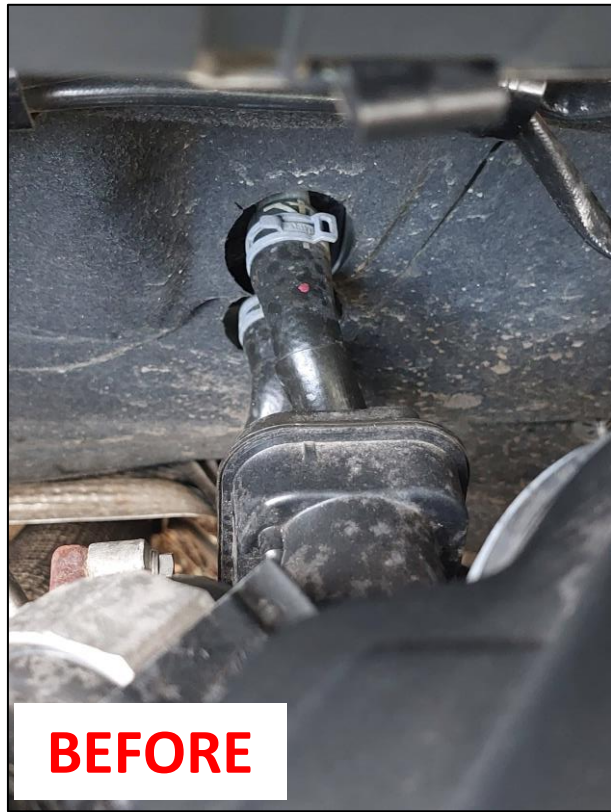
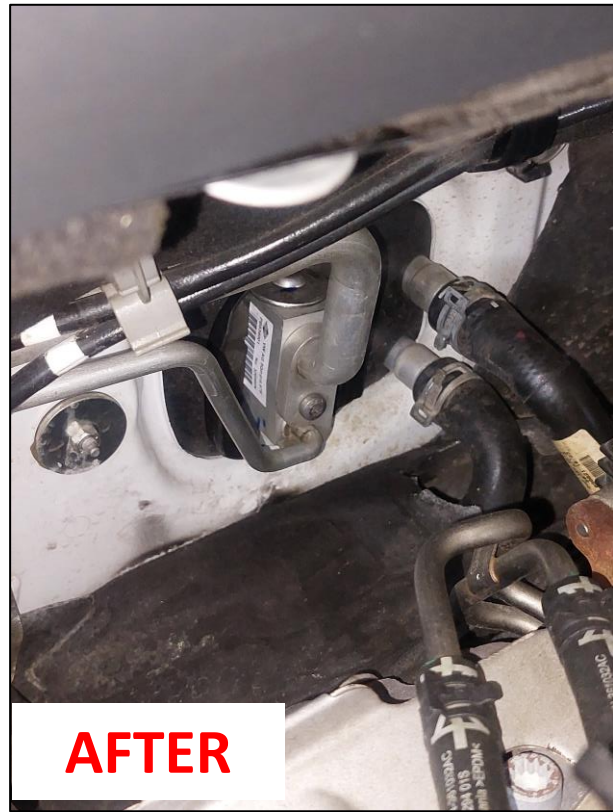
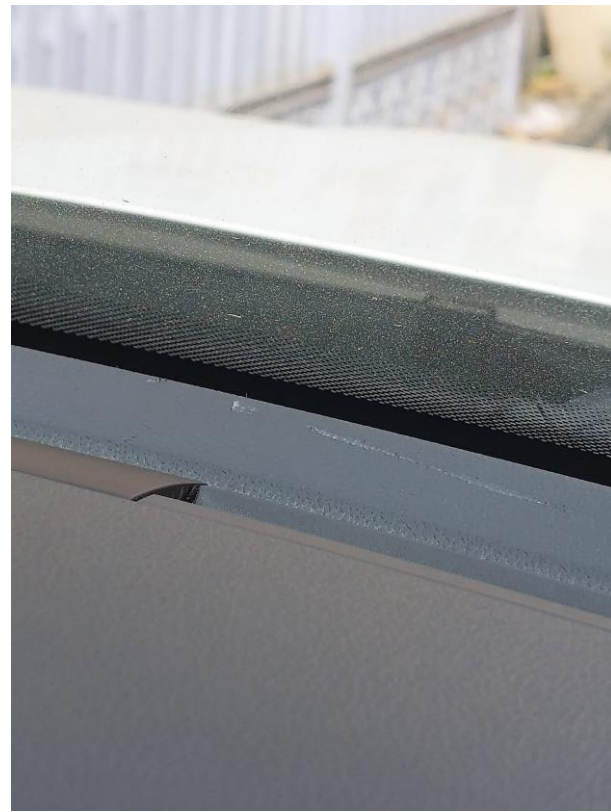
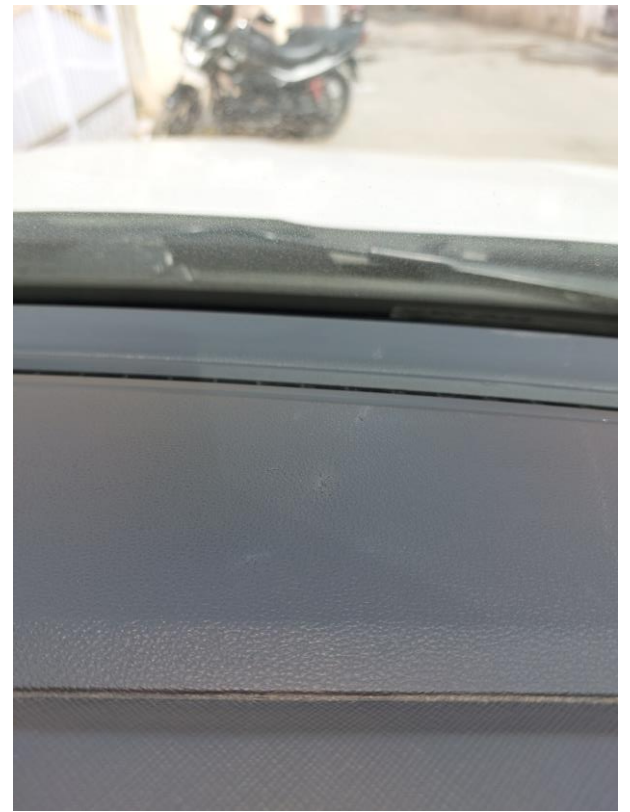
- Red Circle:** Caps missing which were available before procedure. I do not want to risk another leakage due to a missing cap with quality of parts under question.
- Yellow Box:** Addition of new parts – A rectangular part is visible which wasn't available before. Observed this is a domestic made EGELHOF but I was apprised the whole system was made my MAHLE. Also missing black insulation cloth/cover
- Green Box:** The metallic heat insulator looks like is fixed with an after thought. The stock fit is missing.
- Blue Box:** Resemble bad handling of parts
