2012 REPAIR v/s REPLACEMENT GUIDE

BODY AND PAINT

Version 01

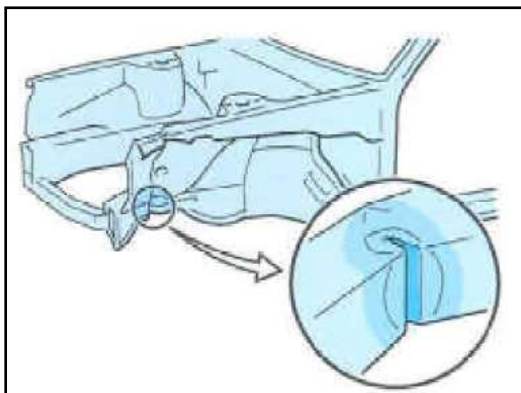
*Material Kink Damage –

A kink is a state of the material that is sharply crimped within a **small area**. The existence of the damage can be easily verified by visual inspection. Kinked material cannot be reinstated to its original shape through aligning, and could lead to cracks or work hardening through pulling. As a result, the body will not be able to absorb the impact of collision as designed. Since the structure parts were designed to exhibit a 100% performance when they were in original shape, if they are deformed in an accident, or if the deformed parts are repaired or reused, then it will be unable to exhibit the same performance as intended in the design. **Therefore, material in which a KINK is present must be REPLACED.**

A bend is the state of the material that is deformed continuously and smoothly within a **wide area**. Often, the existence of the damage that cannot be verified by visual inspection alone. Bent material can be reinstated to its original shape through aligning, without leaving a significant permanent deformation.
