**Suzuki Baleno**  
Standard Safety Equipment

2016

Tested Model	Suzuki Baleno
Body Type	5 door hatchback
Year Of Publication	2016
Kerb Weight	890kg
VIN From Which Rating Applies	- all Balenos
Class	Supermini

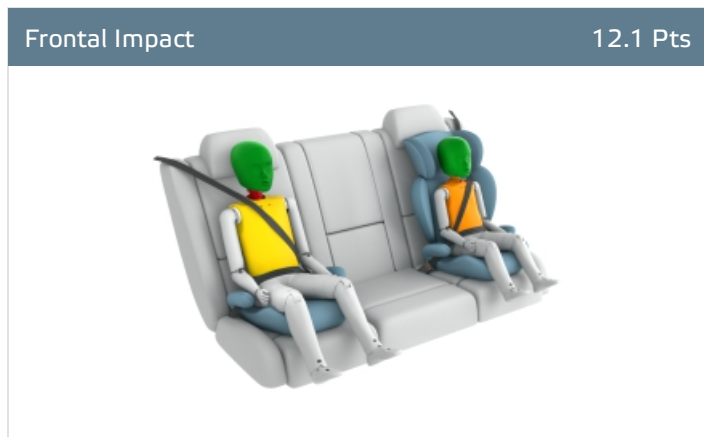
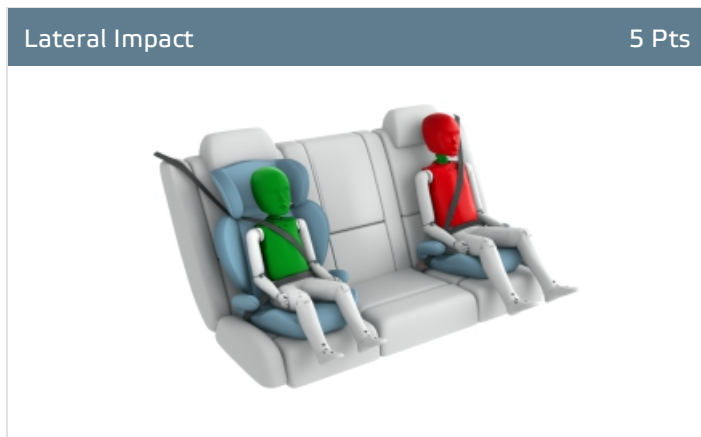
Crash Test Performance based on 6 & 10 year old children

17.1 Pts

Restraint for 6 year old child: *Römer Kid Fix 'XP'*  
 Restraint for 10 year old child: *Fisher Price Safe Voyage*  
**Safety Features**

In the frontal impact, both the 6 and the 10 year dummies were properly restrained and forward movement was not excessive. However, dummy readings revealed high values of neck tensile forces in the 10 year dummy and marginal protection of the neck and chest of the six year dummy. In the side impact, there was insufficient pressure in the side curtain airbag to prevent the head of the 10 year dummy striking the interior of the car, around the C-pillar. This contact led to very high decelerations and protection was rated as poor. Dummy readings of chest deceleration also indicated poor protection of that part of the body. The side wing of the child restraint used for the six year dummy was found to be broken after the test. High-speed film revealed that the dummy's head was not properly contained during the impact, increasing the likelihood of head contact with parts of the car interior. The front passenger airbag can be disabled to allow a rearward-facing child restraint to be used in that seating position. Clear information is provided to the driver regarding the status of the airbag and the system was rewarded.
