ANCAP Safety Rating: TOYOTA FORTUNER (August 2015 – onwards)

Make / Model	Toyota Fortuner
Year Range	August 2015 - onwards
Variant(s)*	All variants
Vehicle Type	Large SUV

ANCAP and ASEAN NCAP conducted crash tests on the Toyota Hilux utility. ANCAP was provided with evidence showing that the results apply to the Fortuner sports utility vehicle, which is based on the Hilux.

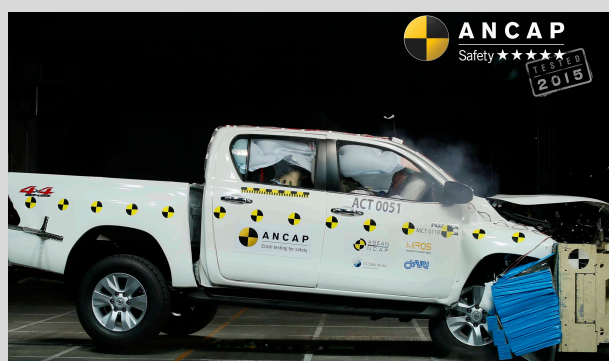
Frontal Offset test at 64km/h (Toyota Hilux tested)

Head / neck:	3.00 points
Chest:	4.00 points
Upper legs:	4.00 points
Lower legs:	2.45 points

The passenger compartment held its shape well in the offset test. Pedal and steering wheel displacements were well controlled. The driver's head made contact with the steering wheel through the airbag. All doors remained closed during the crash. After the crash all doors could be opened with normal effort.
